FUTURE IMPROVEMENTS 531 DANA STREET

Stork, Wolfe & Associates

Re: 531 Dana Street
Structural Inspection

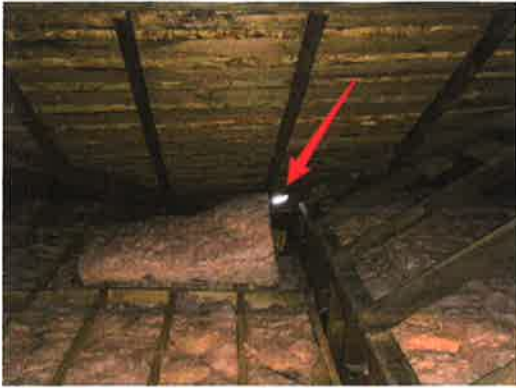
SU s-102: Evidence of past rodents living in the attic, crawlspace and/or other areas, visible rodent droppings. Contact a qualified pest control professional for additional comments and recommendations. Determining if condition is old or active is outside the scope of this inspection.

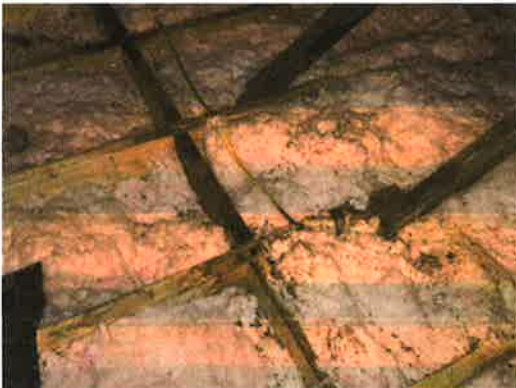
E&C SU FI s-103: Attic framing found damaged and improperly repaired in many locations. Further evaluation and corrections recommended. Contact a qualified professional.

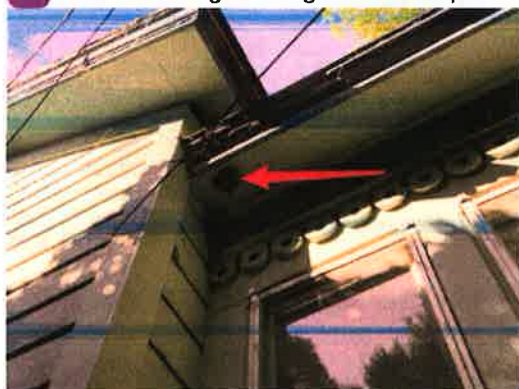
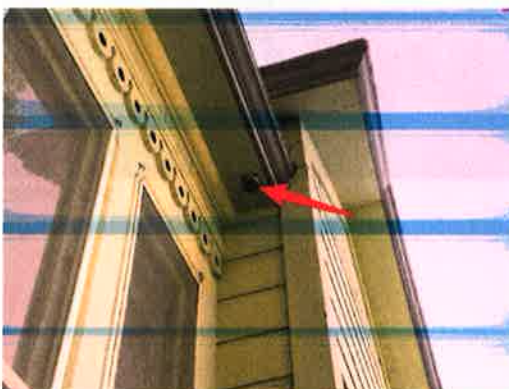
E&C s-93: Missing a rain gutter downspout: NORTHWEST CORNER AND SOUTHWEST CORNER

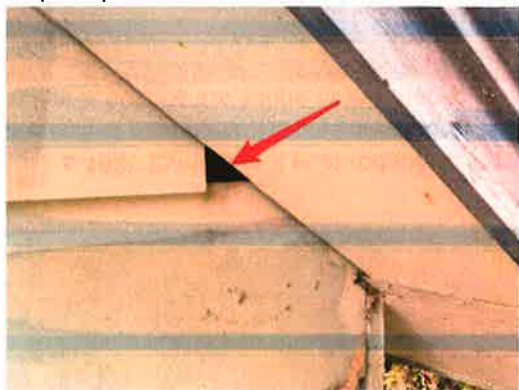
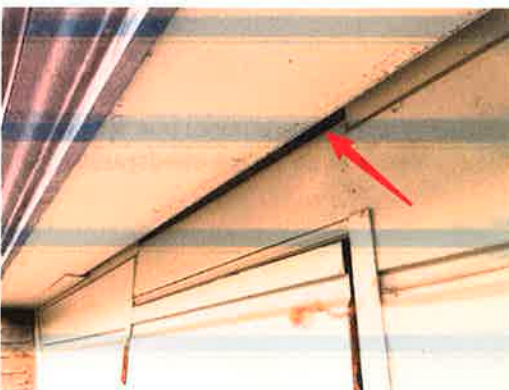
E&C SC s-101: Unprotected openings into the attic from the exterior should to be sealed or screened per standards to help keep critters out of the attic.

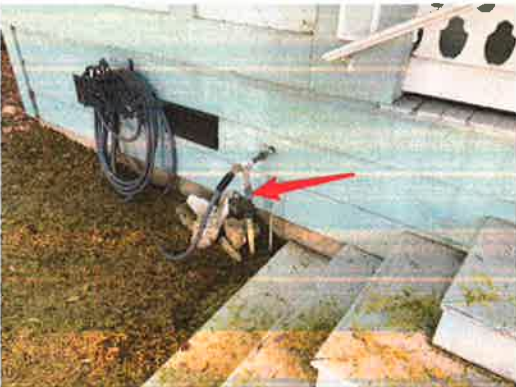
104: Main water supply shut-off location: **West Side.** - Main water shut-off valve not tested.

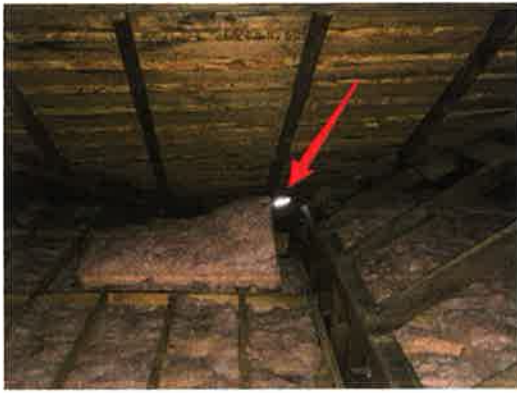
SU **102:** Evidence of past rodents living in the attic, crawlspace and/or other areas, visible rodent droppings. Contact a qualified pest control professional for additional comments and recommendations. Determining if condition is old or active is outside the scope of this inspection.

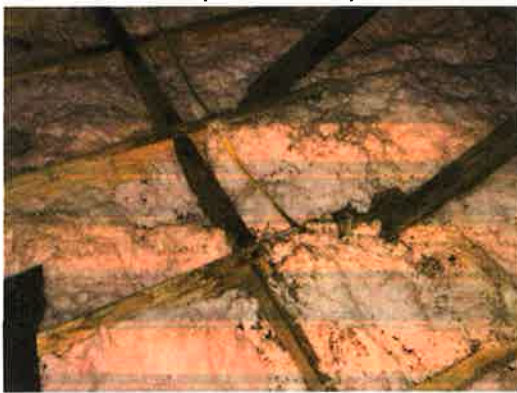
E&C **SU** **FI** **103:** Attic framing found damaged and improperly repaired in many locations. Further evaluation and corrections recommended. Contact a qualified professional.

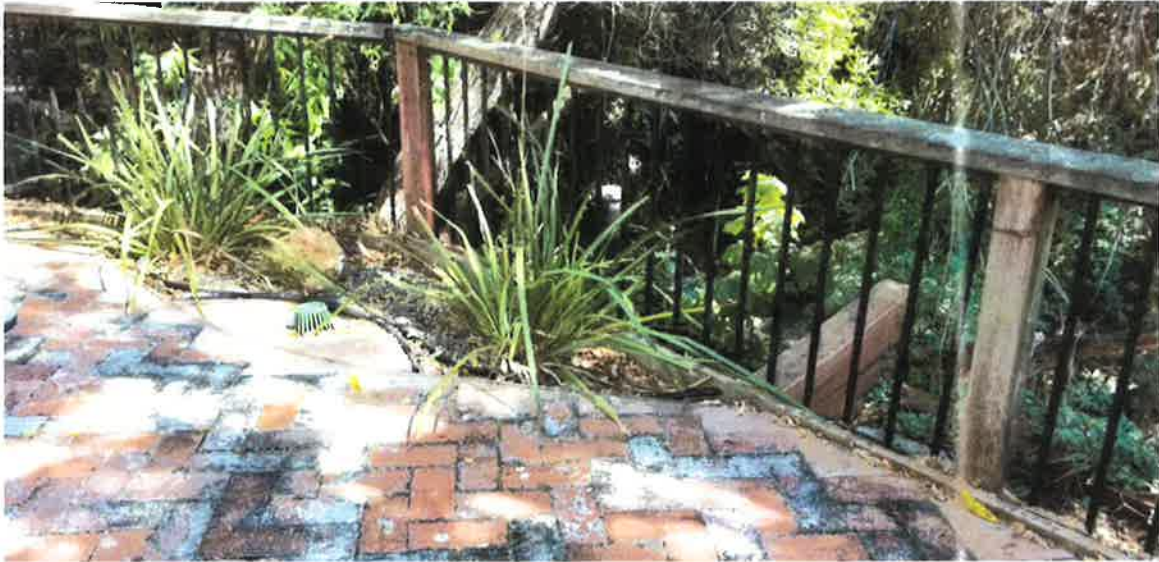
Figure 1 – Retaining wall at backyard upper patio.

We have completed our review of the terraced backyard retaining walls at 531 Dana Street in San Luis Obispo. The retaining walls consist of wood boards spanning horizontally to wood posts embedded in concrete footings [Figure 1]. Although the exact date of construction is unknown it appears to have been constructed within the past 20 to 30 years. Considering the elevation difference between the upper street level, and the lowest patio level, this type of retaining wall system is structurally insufficient to support the retained soil loads. This is evident by rotation at the base of the posts at all levels of the terraced yard, which has caused the walls to lean, the paving to separate from adjacent walls, and a very noticeable slope towards the creek [Figures 2 & 3].

Due to the insufficient soil-retention system, future soil and retaining wall movement is expected to continue until complete slope failure occurs. It is recommended that all wood retaining walls be replaced with reinforced concrete or masonry walls with proper foundations designed by a licensed civil or structural engineer.

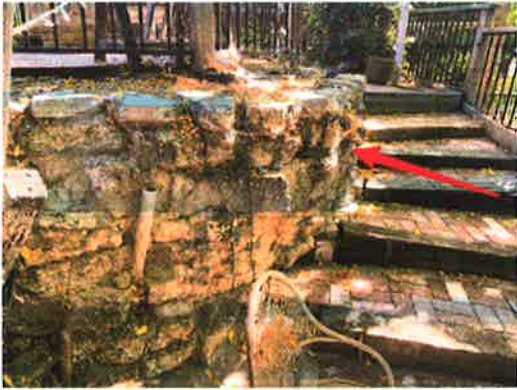
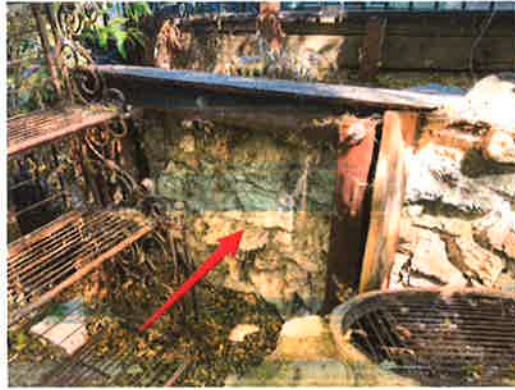
E&C SC FI 52: The East retaining walls adjacent to the creek are constructed of non-steel-reinforced concrete waste. Multiple areas of the walls appear to be leaning/ failing and may not support soils under load. Contact a qualified engineer for further evaluation.

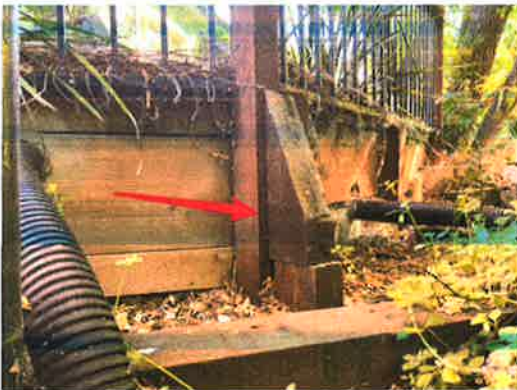
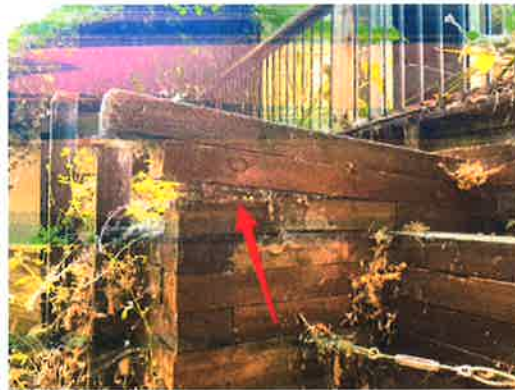
E&C SC FI 53: Areas of the east wood retaining walls/ retaining wall repairs do not appear to meet construction standards. Evaluation recommended.

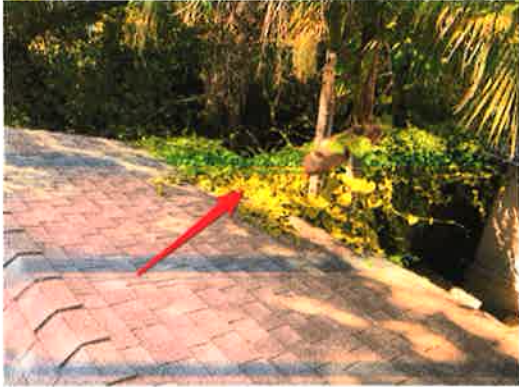
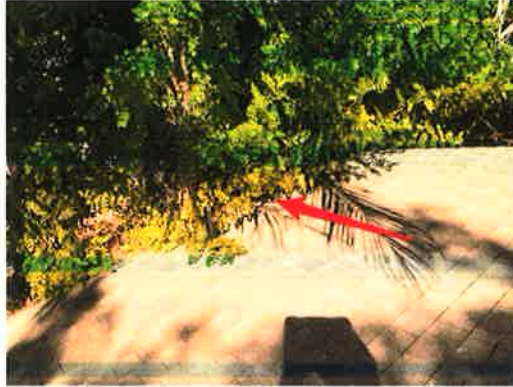
MR 49: Plants or trees touch the house and/or roof. Proper landscape maintenance warranted /recommended.

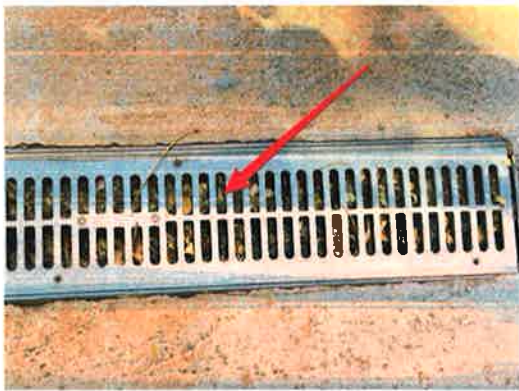
MR 51: Surface and/or yard drain boxes found full of debris. Recommend having drains tested to determine proper flow and termination.

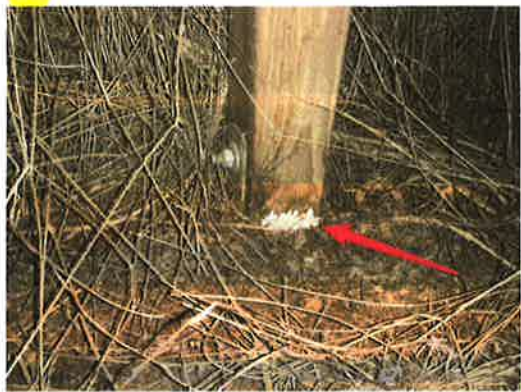
MR s-45: Earth-to-wood contact visible at areas of the wood deck framing.

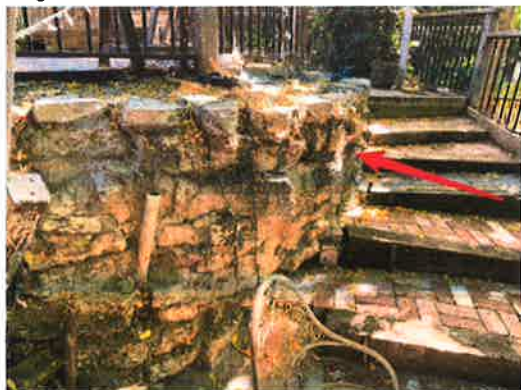
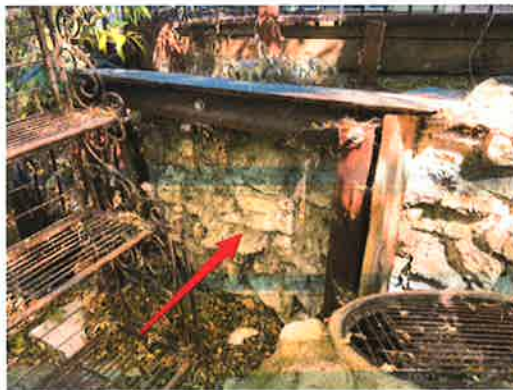
E&C SC FI s-52: The East retaining walls adjacent to the creek are constructed of non-steel-reinforced concrete waste. Multiple areas of the walls appear to be leaning/ failing and may not support soils under load. Contact a qualified engineer for further evaluation.

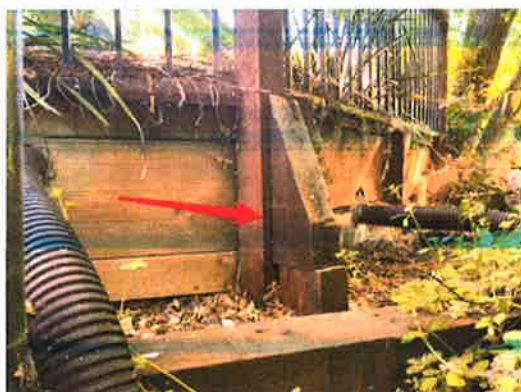
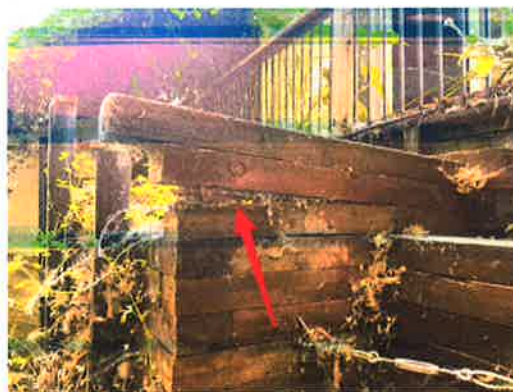
E&C SC FI s-53: Areas of the east wood retaining walls/ retaining wall repairs do not appear to meet construction standards. Evaluation recommended.

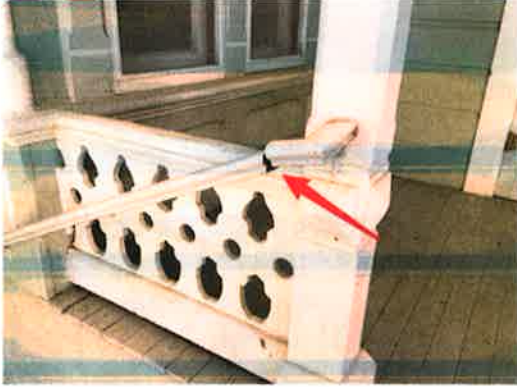
E&C SC s-41: The handrail at the entry stairway/ steps found damaged.

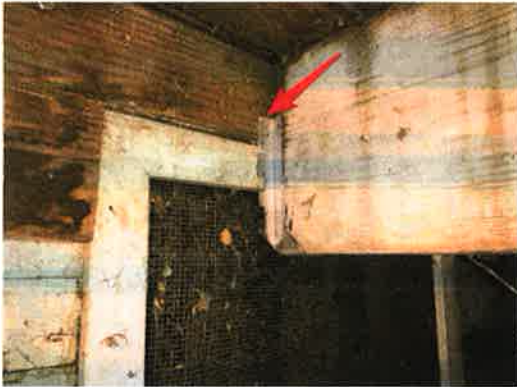
E&C SU s-43: Areas of the BACKYARD WOOD DECK and STAIRS do not meet minimum construction standards. Recommend further review and repairs by a qualified licensed contractor familiar with minimum construction and engineering standards.

Multiple deck joists held on by single nails

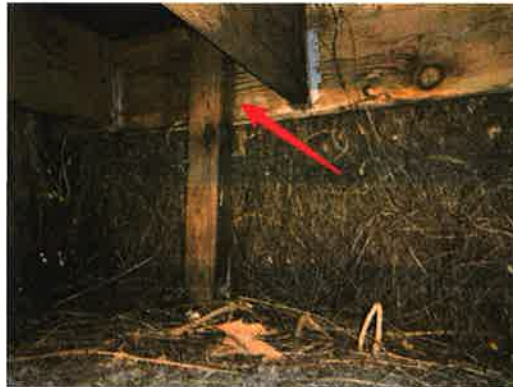
Improper post to beam connections throughout

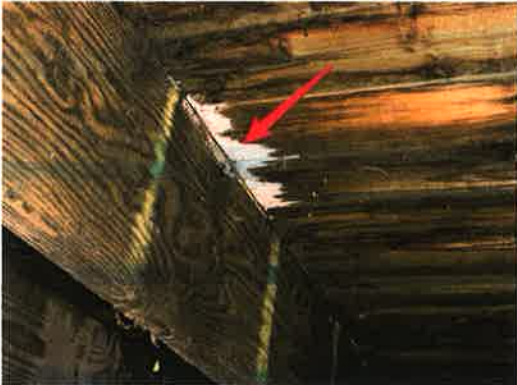
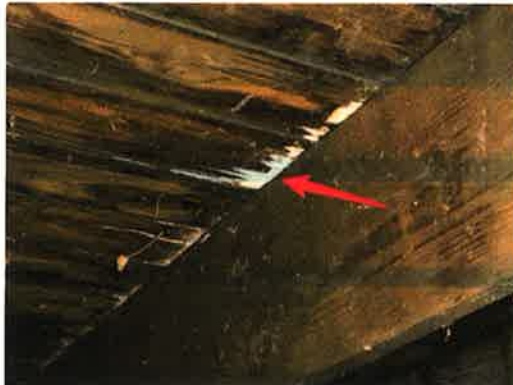
E&C SC s-44: Some moisture and/or bug type damage and deterioration, visible fungus growth found at areas of the wood decking and/or wood deck railings. *Refer to the termite report for additional comments and recommendations.*

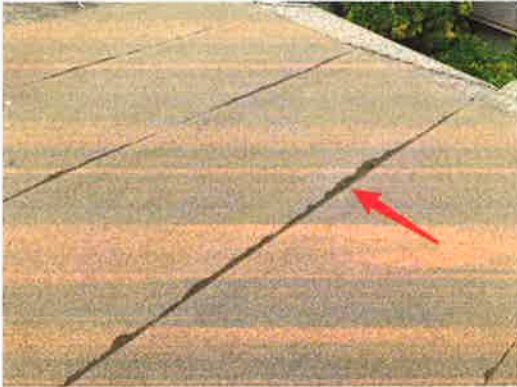
MR 81: Areas of past improper or incomplete past repairs found at areas of the ROLLED COMPOSITION ROOFING. Areas of exposed mastic found not covered by aggregate found deteriorated.

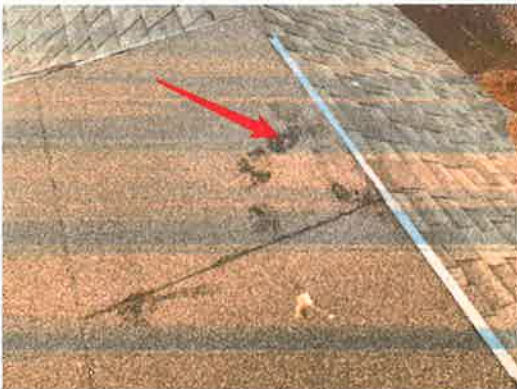
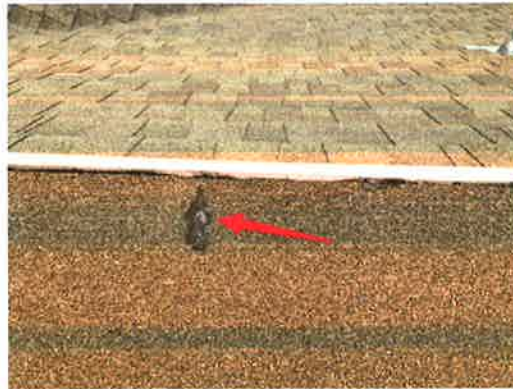
E&C 82: Exposed, bare areas of the roof found deteriorated and prone to further sun damage needing repair or maintenance.

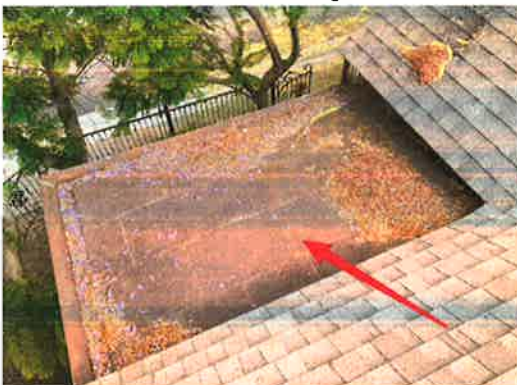
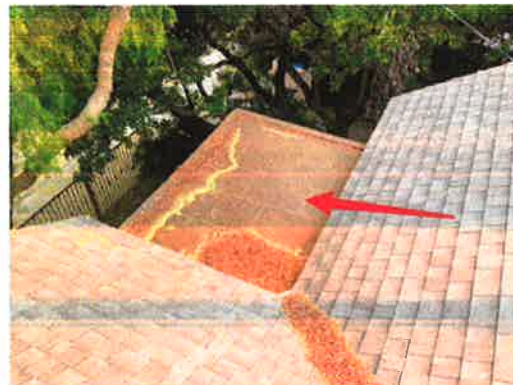
E&C MR 86: Recommend coating the original metal roofs over the Southwest and northwest corners as part of typical maintenance. Roofs show signs of moderate rust/ deterioration.

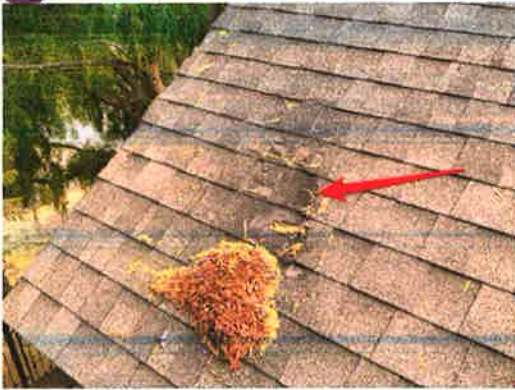
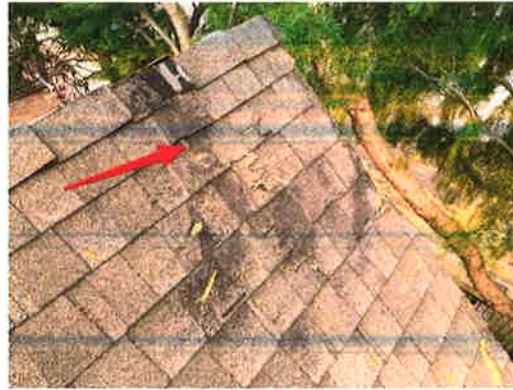
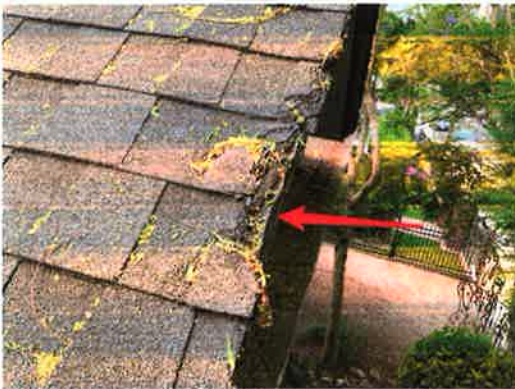
E&C 75: Some damaged / deteriorated / missing roof shingles. Correction needed.

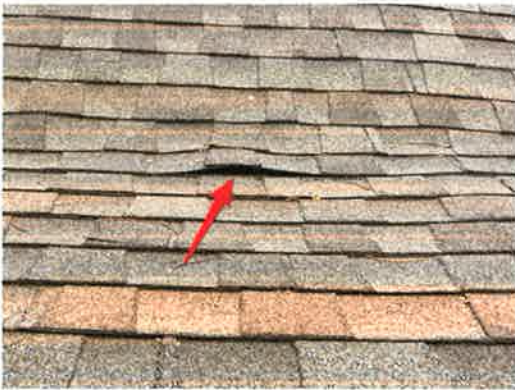
MR 76: Some loose and lifting roof shingles found at areas of the asphalt composition roof. Maintenance and/or repairs Recommended.

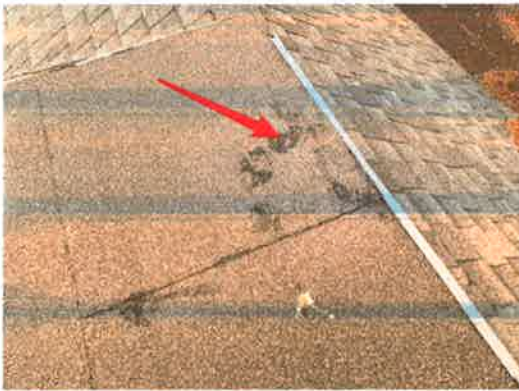
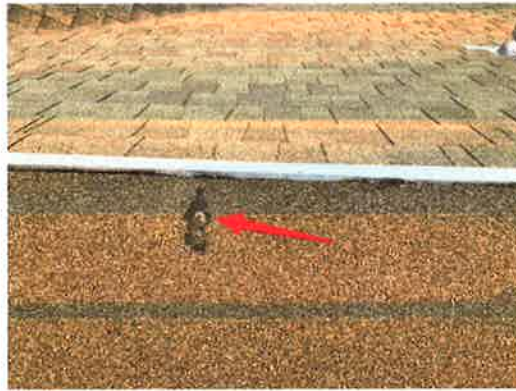
E&C s-82: Exposed, bare areas of the roof found deteriorated and prone to further sun damage needing repair or maintenance.

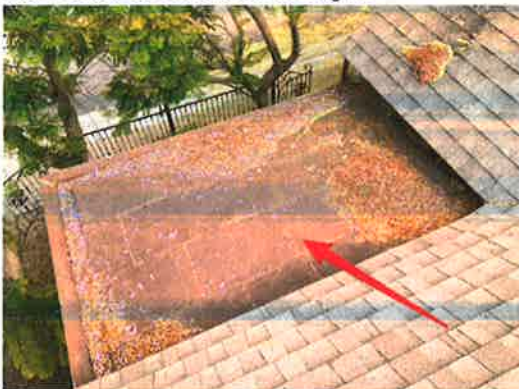
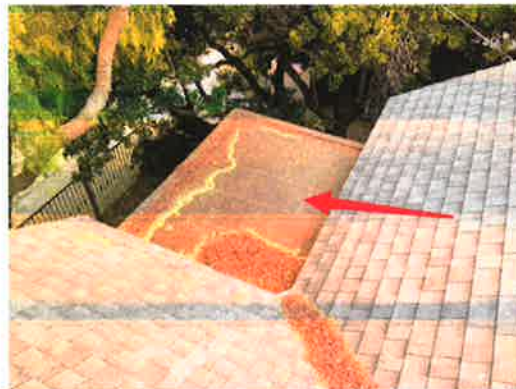
E&C MR s-86: Recommend coating the original metal roofs over the Southwest and northwest corners as part of typical maintenance. Roofs show signs of moderate rust/ deterioration.

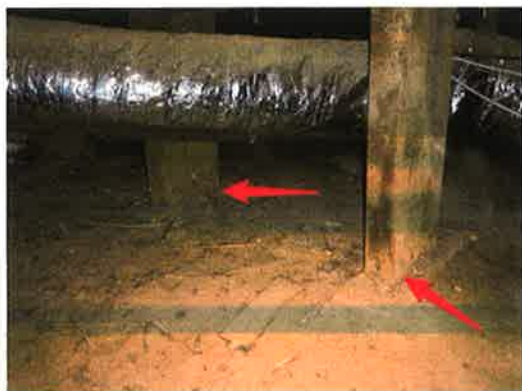
E&C s-67: Earth-to-wood contact found in areas of the crawlspace. Upgrades recommended. Refer to termite report for locations.

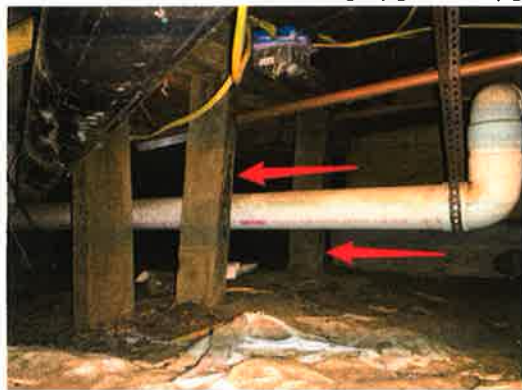
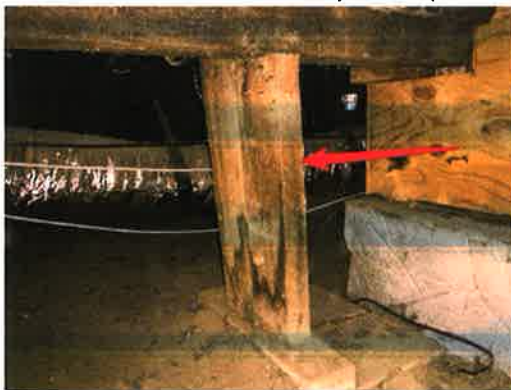
E&C FI s-68: A few structural support posts in the crawlspace found leaning and do not meet current standards. Further evaluation and framing upgrades recommended. Contact a qualified professional.

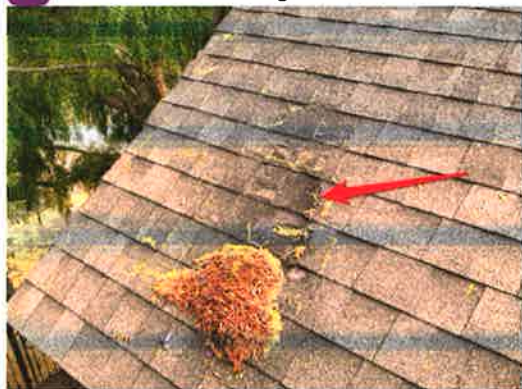
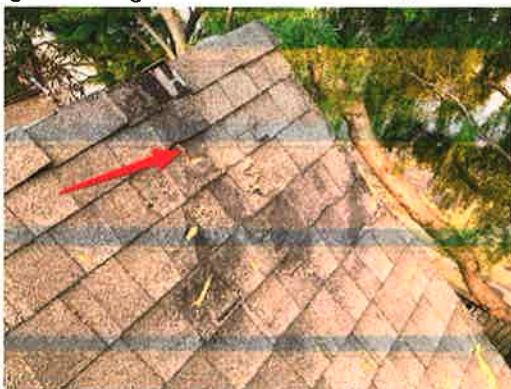
E&C s-75: Some damaged / deteriorated / missing roof shingles. Correction needed.
