2025 Whale Rock 30" Waterline Cathodic Protection Survey

Report – Cathodic Protection Services

Issued To: **City of San Luis Obispo**

Document ID: **ACUUS-J212126-RSV-0.0**

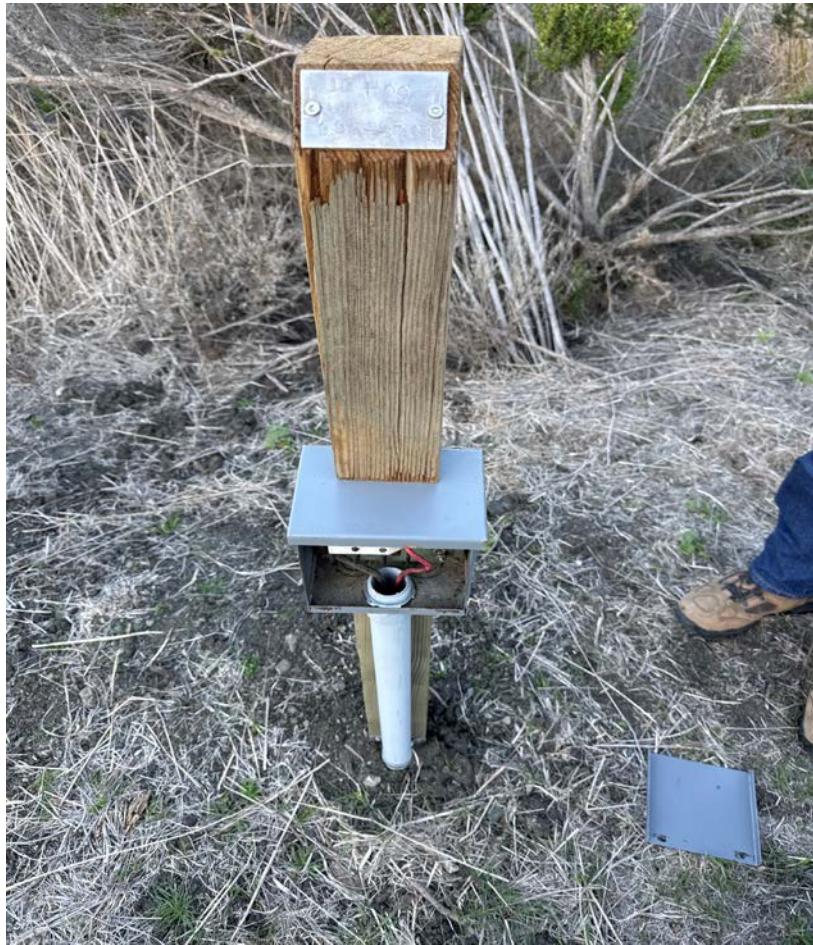
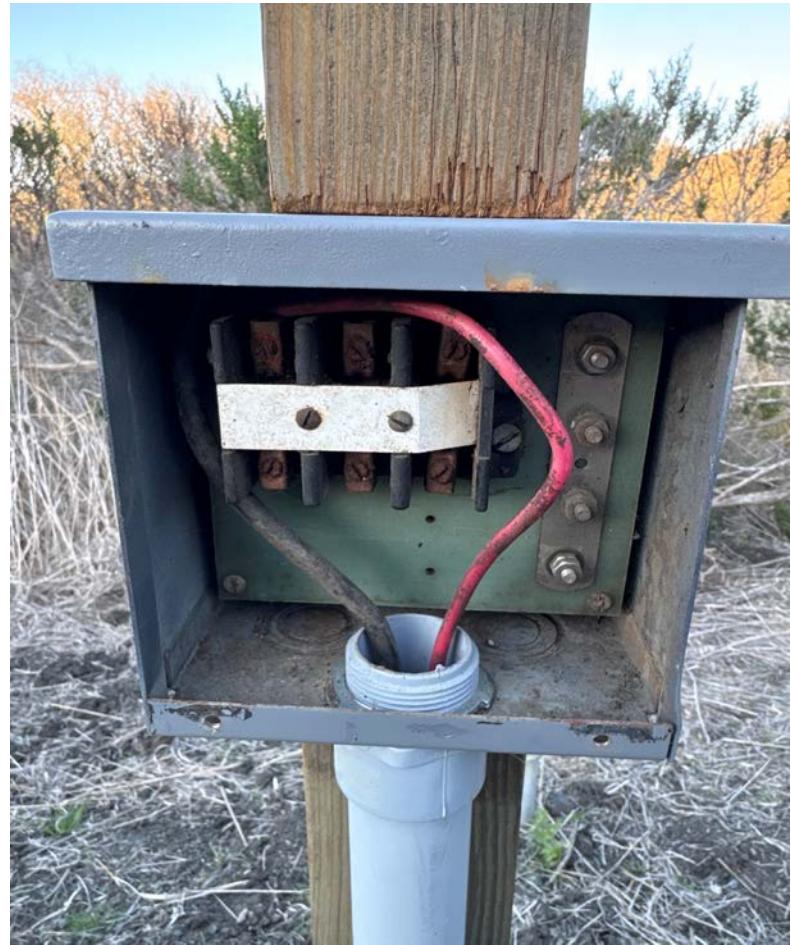
2025 CP Survey – TP 10+00

SOL-0006	TP 10+00	Inadequate Cathodic Protection	1	Water Piping System	Test point not meeting 100mV / 850mV criterion.	Re-establish galvanic anode connection and allow to polarize.		Acuren		Monitor	12/30/2025		
SOL-0007	TP 48+00	Inadequate Cathodic Protection	1	Water Piping System	Test point not meeting 100mV / 850mV criterion.	Consider installing galvanic anode at this location		Acuren		Monitor	12/30/2025		
SOL-0008	TP 63+00	Inadequate Cathodic Protection	1	Water Piping System	Test point not meeting 100mV / 850mV criterion.	Consider installing galvanic anode at this location		Acuren		Monitor	12/30/2025		
SOL-0009	TP 65+85	Inadequate Cathodic Protection	1	Water Piping System	Test point not meeting 100mV / 850mV criterion.	Consider installing galvanic anode at this location		Acuren		Monitor	12/30/2025		
SOL-0010	TP 71+30	Inadequate Cathodic Protection	1	Water Piping System	Test point not meeting 100mV / 850mV criterion.	Consider installing galvanic anode at this location		Acuren		Monitor	12/30/2025

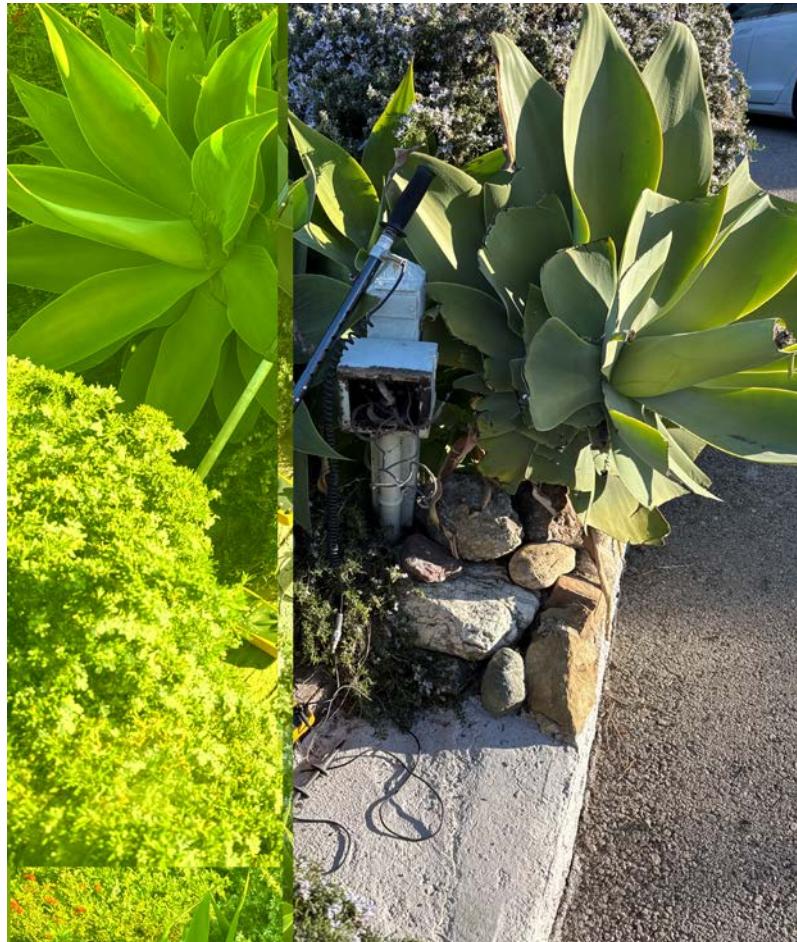
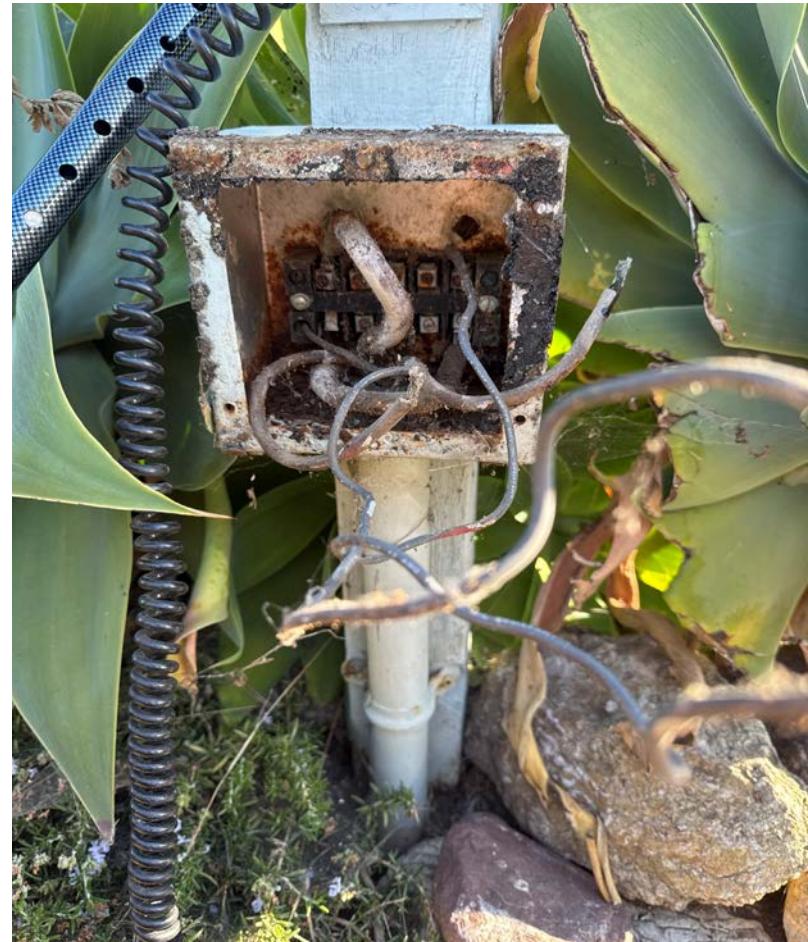
2025 CP Survey – TP 71+30

Galvanic Anode Description	Location	Anode Output (mA)	Notes
Magnesium	10+00	0.0	Anode disconnected
Magnesium	71+30	0.0	Anode depleted
Magnesium	96+30	0.0	Anode depleted
Magnesium	96+30	0.0	Anode disconnected (Rear)
Magnesium	130+00	NR	Anode present and functional
Magnesium	157+00	0.0	Anode disconnected
Magnesium	165+00	0.0	Anode depleted
Magnesium	180+25	0.0	Anode(s) disconnected
Magnesium	207+00	0.0	Anode(s) disconnected
Magnesium	227+00	0.0	Anode depleted
Magnesium	295+05	0.0	Anode disconnected
Magnesium	300+00	NR	Anode present and functional
Magnesium	310+90	0.0	Anode disconnected
Magnesium	313+90	0.0	Anode(s) disconnected
Magnesium	397+25	0.0	Anode(s) disconnected
Magnesium	515+00	0.0	Anode disconnected
Magnesium	559+30	0.0	Anode depleted
Magnesium	579+00	0.0	Anode disconnected
Magnesium	602+50	0.0	Anode disconnected
Magnesium	602+50	0.0	Anode disconnected (Rear)

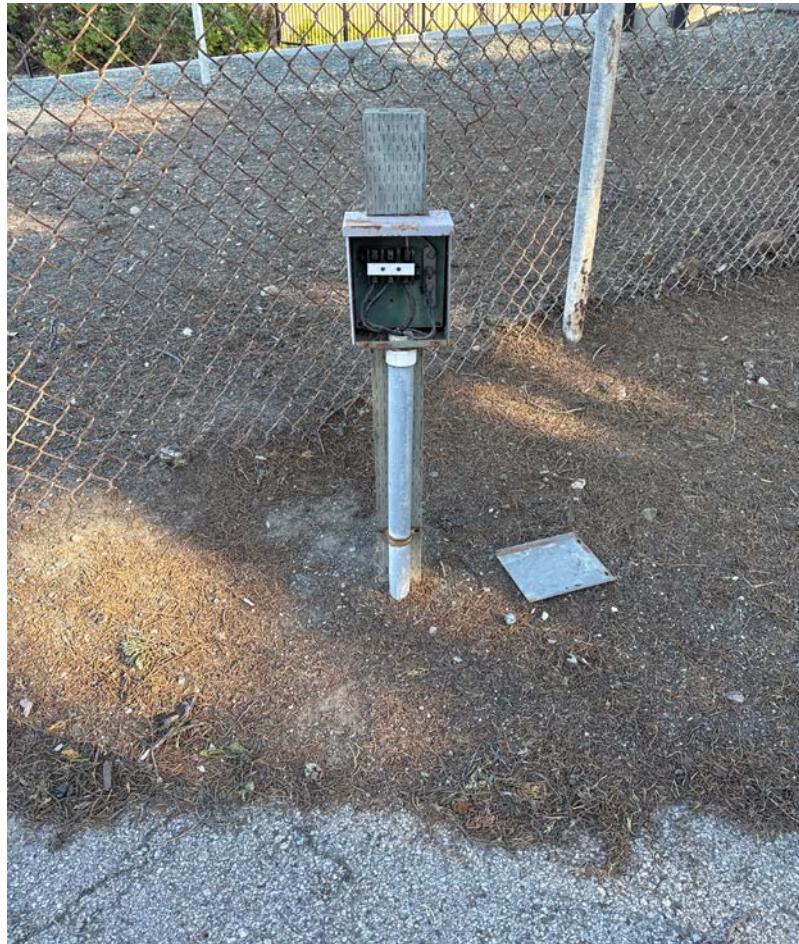
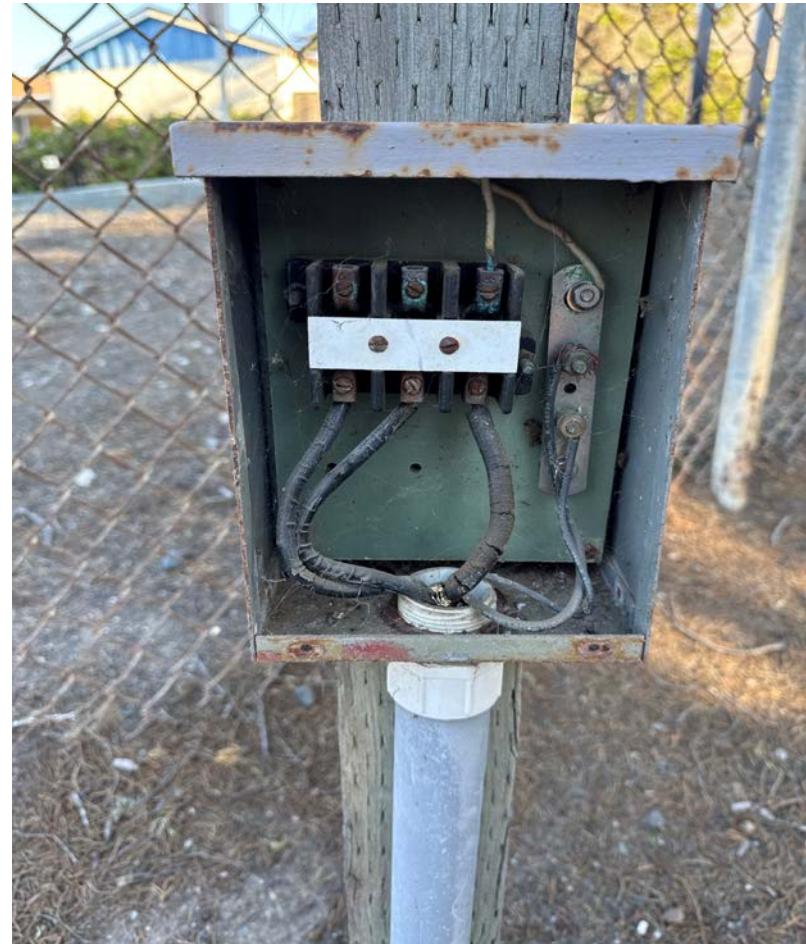
2025 CP Survey – TP 96+30

SOL-0011	TP 96+30	Inadequate Cathodic Protection	1	Water Piping System	Test point not meeting 100mV / 850mV criterion.	Re-establish galvanic anode connection and allow to polarize.		Acuren		Monitor	12/30/2025		
SOL-0012	TP 139+00	Inadequate Cathodic Protection	1	Water Piping System	Test point not meeting 100mV / 850mV criterion.	Consider installing galvanic anode at this location		Acuren		Monitor	12/30/2025		
SOL-0013	TP 143+00	Inadequate Cathodic Protection	1	Water Piping System	Test point not meeting 100mV / 850mV criterion.	Consider installing galvanic anode at this location		Acuren		Monitor	12/30/2025		
SOL-0014	TP 157+00	Inadequate Cathodic Protection	1	Water Piping System	Test point not meeting 100mV / 850mV criterion.	Re-establish galvanic anode connection and allow to polarize.		Acuren		Monitor	12/30/2025		
SOL-0015	TP 160+00	Inadequate Cathodic Protection	1	Water Piping System	Test point not meeting 100mV / 850mV criterion.	Consider installing galvanic anode at this location		Acuren		Monitor	12/30/2025

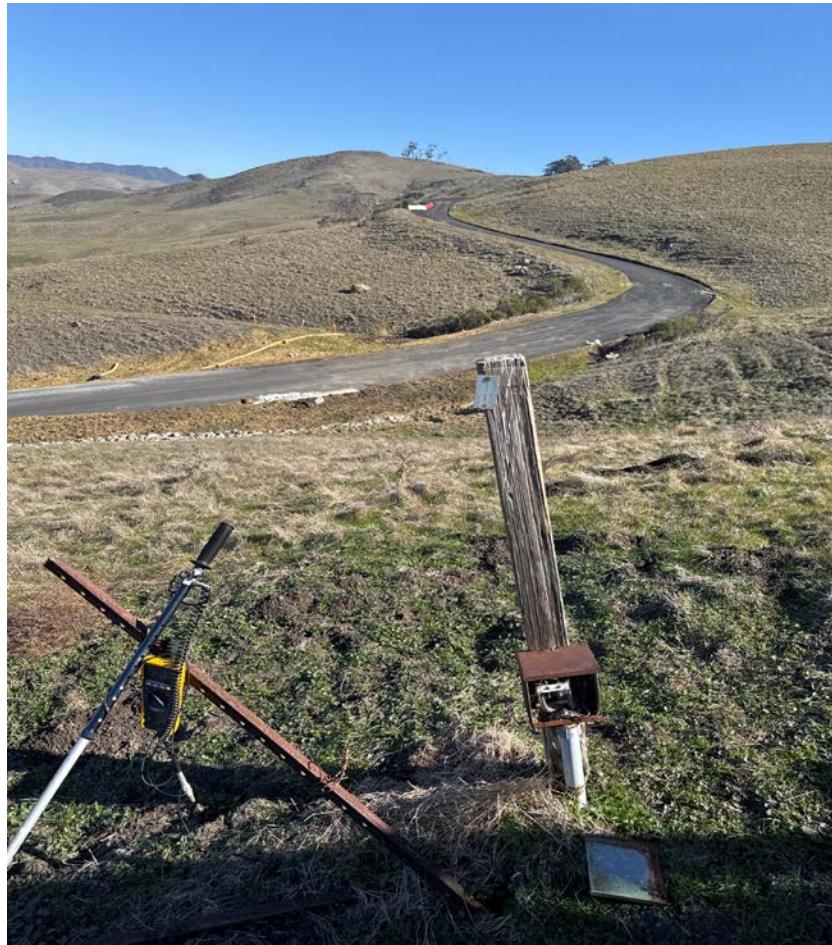
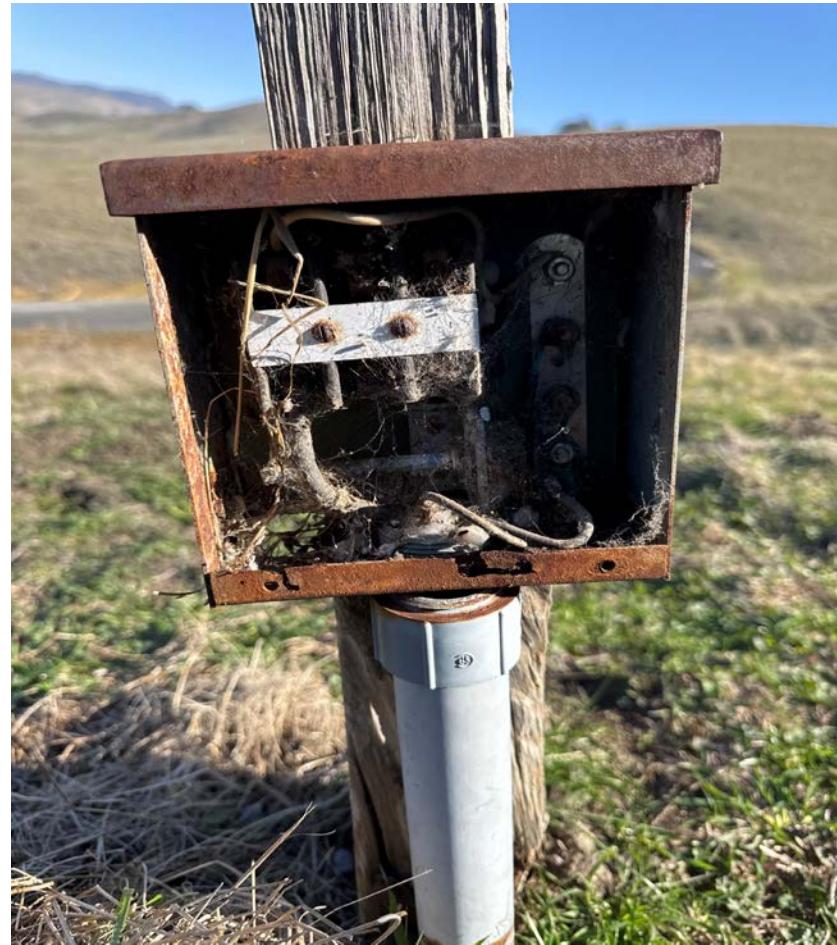
2025 CP Survey – TP 165+00

SOL-0016	TP 165+00	Inadequate Cathodic Protection	1	Water Piping System	Test point not meeting 100mV / 850mV criterion.	Consider installing galvanic anode at this location		Acuren		Monitor	12/30/2025		
SOL-0017	TP 176+00	Inadequate Cathodic Protection	1	Water Piping System	Test point not meeting 100mV / 850mV criterion.	Consider installing galvanic anode at this location		Acuren		Monitor	12/30/2025

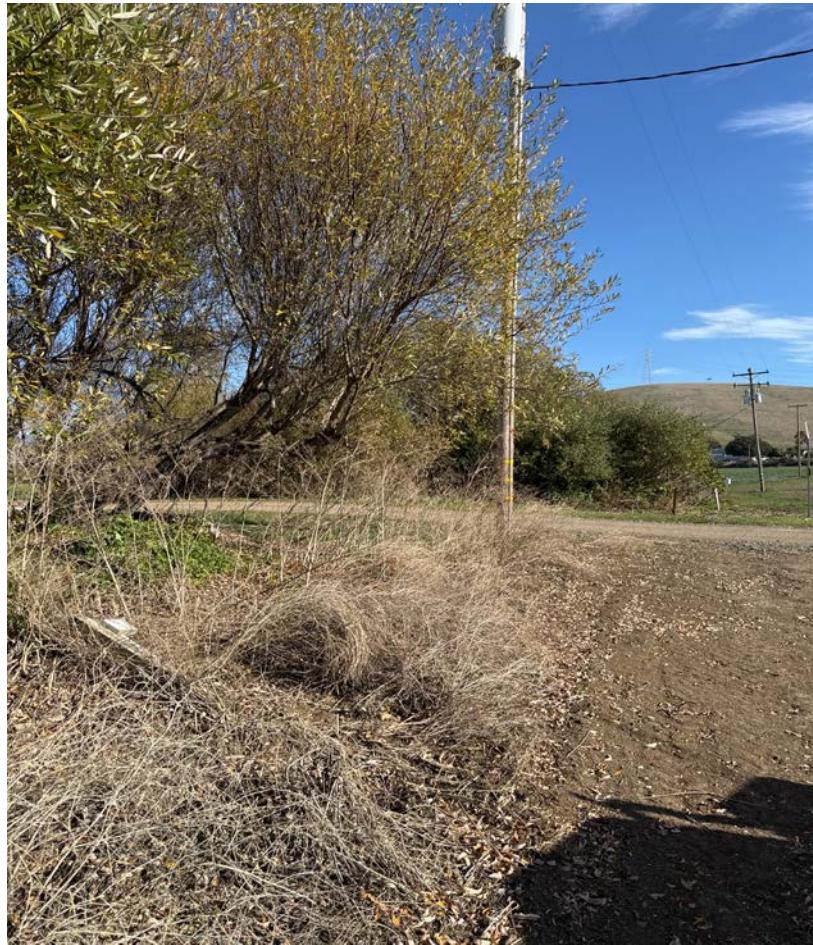
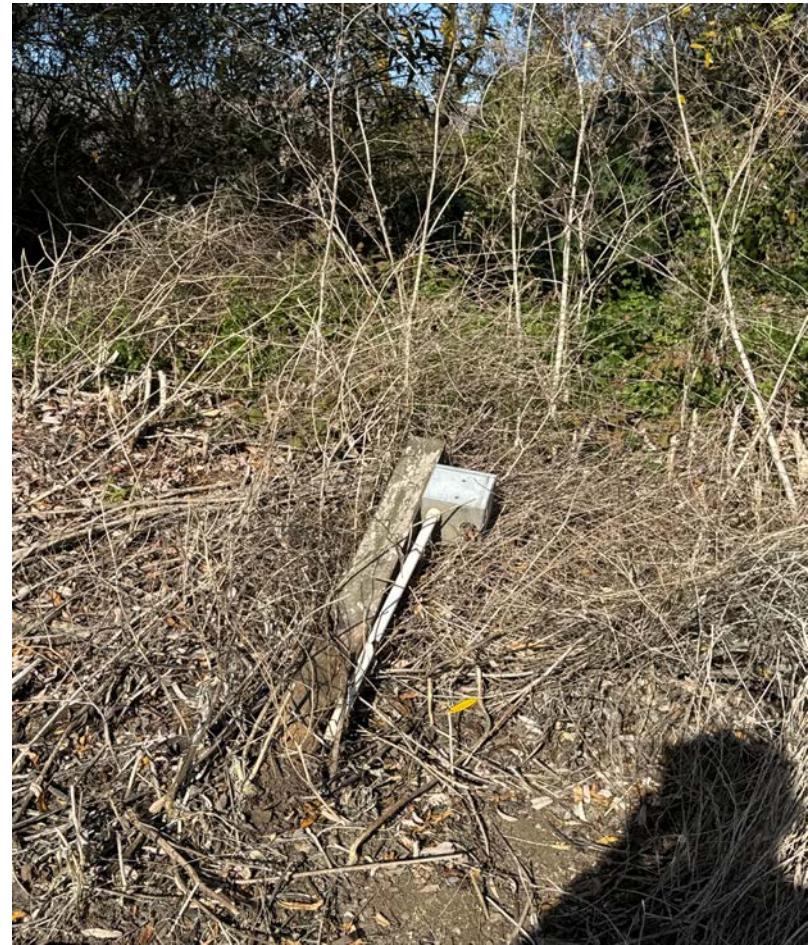
2025 CP Survey – TP 257+10

SOL-0022	TP 257+10	Inadequate Cathodic Protection	1	Water Piping System	Test point not meeting 100mV / 850mV criterion.	Consider installing galvanic anode at this location		Acuren		Monitor	12/30/2025		
SOL-0023	TP 295+05	Inadequate Cathodic Protection	1	Water Piping System	Test point not meeting 100mV / 850mV criterion.	Re-establish galvanic anode connection and allow to polarize.		Acuren		Monitor	12/30/2025		
SOL-0024	TP 310+90	Inadequate Cathodic Protection	1	Water Piping System	Test point not meeting 100mV / 850mV criterion.	Re-establish galvanic anode connection and allow to polarize.		Acuren		Monitor	12/30/2025		
SOL-0025	TP 313+90	Inadequate Cathodic Protection	1	Water Piping System	Test point not meeting 100mV / 850mV criterion.	Re-establish galvanic anode connection and allow to polarize.		Acuren		Monitor	12/30/2025		
SOL-0026	TP 358+00	Inadequate Cathodic Protection	1	Water Piping System	Test point not meeting 100mV / 850mV criterion.	Consider installing galvanic anode at this location		Acuren		Monitor	12/30/2025

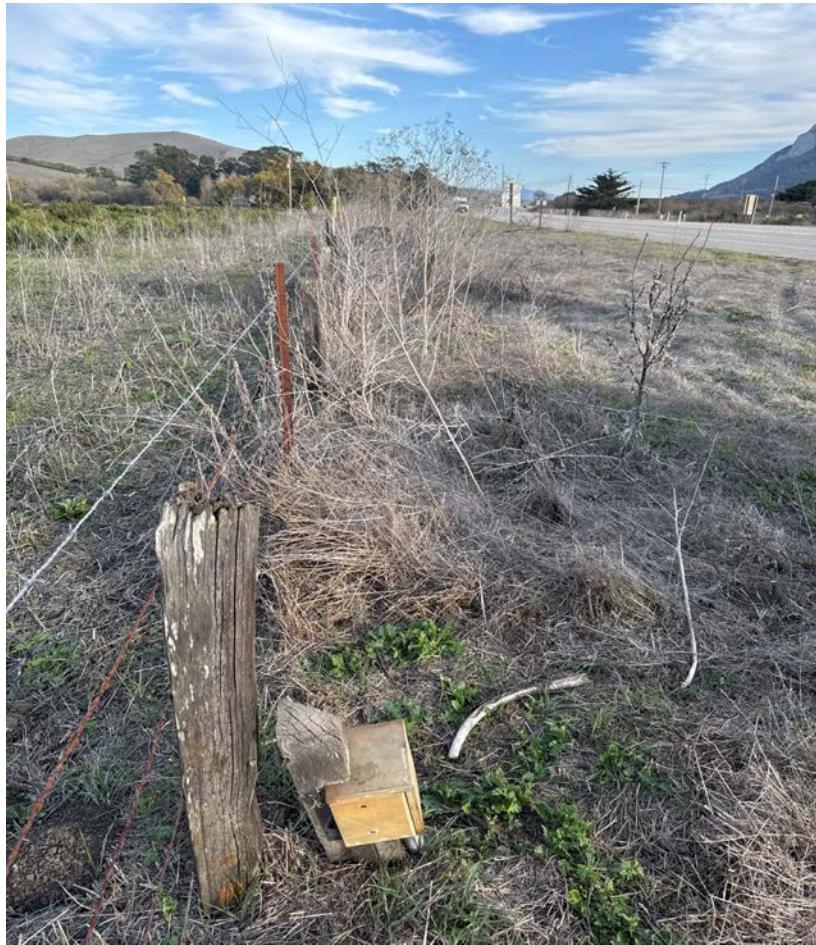
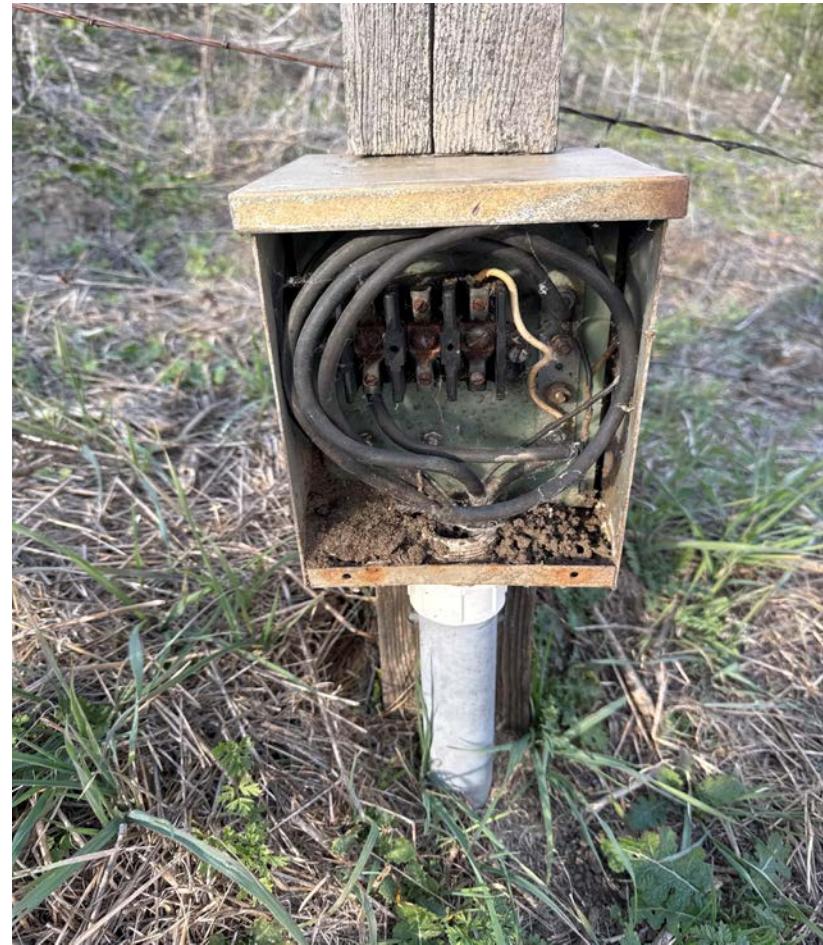
2025 CP Survey – TP 397+25

SOL-0027	TP 397+25	Inadequate Cathodic Protection	1	Water Piping System	Test point not meeting 100mV / 850mV criterion.	Re-establish galvanic anode connection and allow to polarize.		Acuren		Monitor	12/30/2025		
SOL-0028	TP 430+00	Inadequate Cathodic Protection	1	Water Piping System	Test point not meeting 100mV / 850mV criterion.	Consider installing galvanic anode at this location		Acuren		Monitor	12/30/2025		
SOL-0029	TP 461+47	Inadequate Cathodic Protection	1	Water Piping System	Test point not meeting 100mV / 850mV criterion.	Consider installing galvanic anode at this location		Acuren		Monitor	12/30/2025		
SOL-0030	TP 515+00	Inadequate Cathodic Protection	1	Water Piping System	Test point not meeting 100mV / 850mV criterion.	Re-establish galvanic anode connection and allow to polarize.		Acuren		Monitor	12/30/2025		
SOL-0031	TP 559+30	Inadequate Cathodic Protection	1	Water Piping System	Test point not meeting 100mV / 850mV criterion.	Consider installing galvanic anode at this location		Acuren		Monitor	12/30/2025

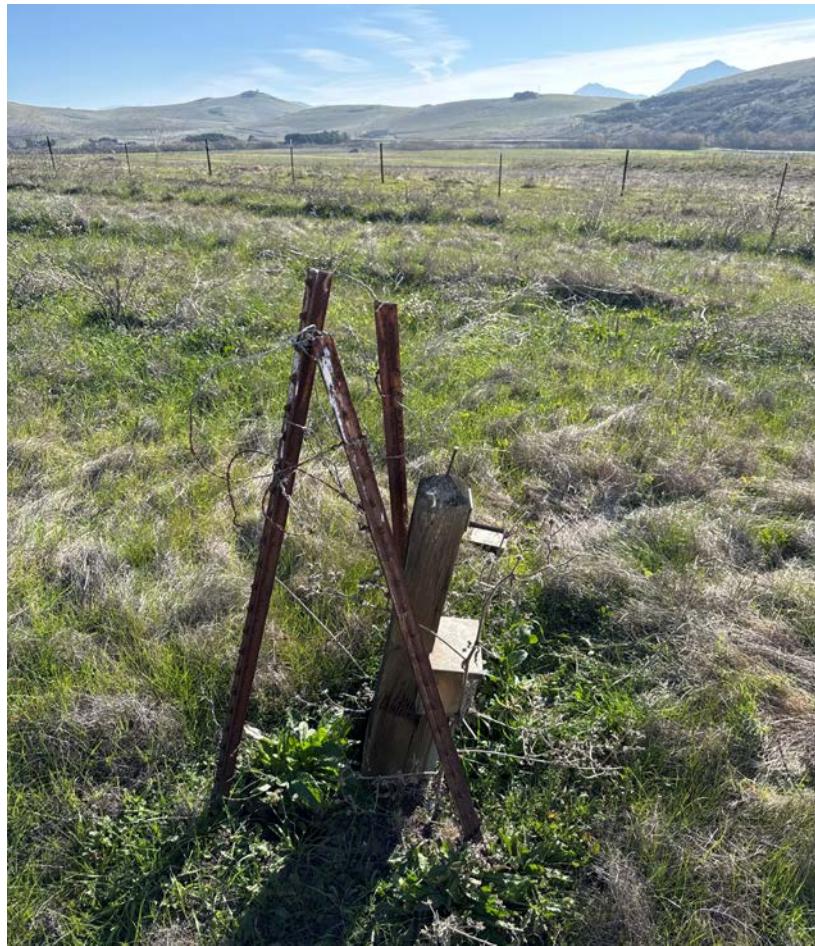
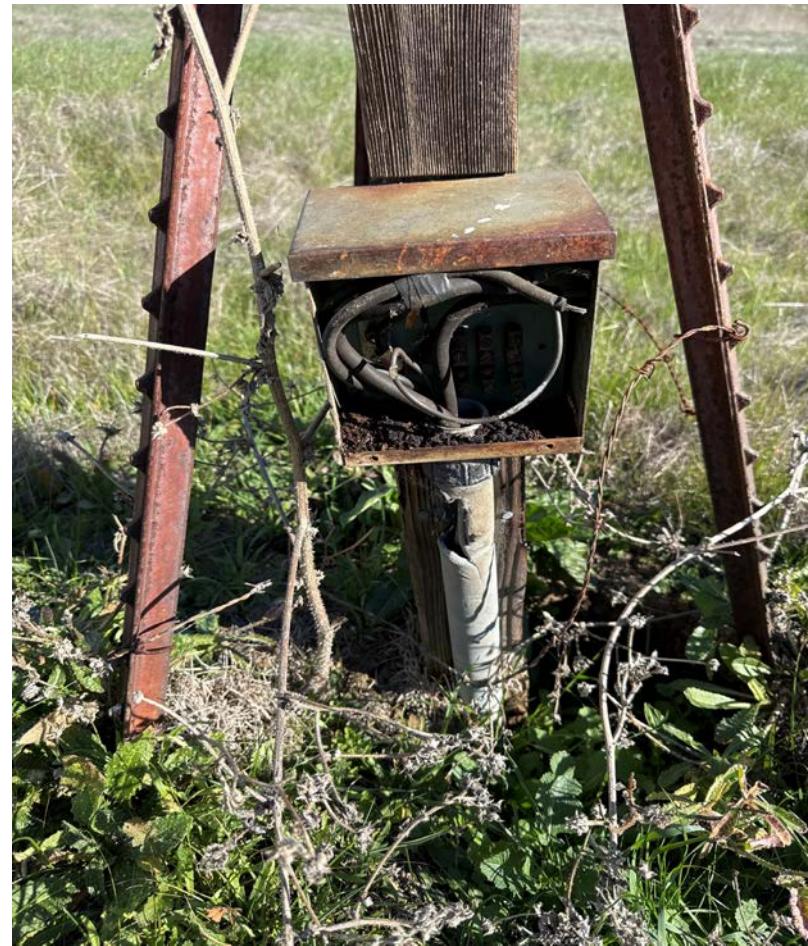
2025 CP Survey – TP 579+00

SOL-0032	TP 579+00	Inadequate Cathodic Protection	1	Water Piping System	Test point not meeting 100mV / 850mV criterion.	Consider installing galvanic anode at this location		Acuren		Monitor	12/30/2025		
SOL-0033	TP 602+50	Inadequate Cathodic Protection	2	Water Piping System	Test point not meeting 100mV / 850mV criterion.	Re-establish galvanic anode connection and allow to polarize.		Acuren		Monitor	12/30/2025		
SOL-0034	PLEX-03	Inadequate Cathodic Protection	2	Water Piping System	Test point not meeting 100mV / 850mV criterion.	Consider installing anode test station.		Acuren	Pipeline Exposure	Monitor	12/30/2025		
SOL-0035	PLEX-04	Inadequate Cathodic Protection	2	Water Piping System	Test point not meeting 100mV / 850mV criterion.	Consider installing anode test station.		Acuren	Pipeline Exposure	Monitor	12/30/2025		
SOL-0036	PLEX-05	Inadequate Cathodic Protection	2	Water Piping System	Test point not meeting 100mV / 850mV criterion.	Consider installing anode test station.		Acuren	Pipeline Exposure	Monitor	12/30/2025

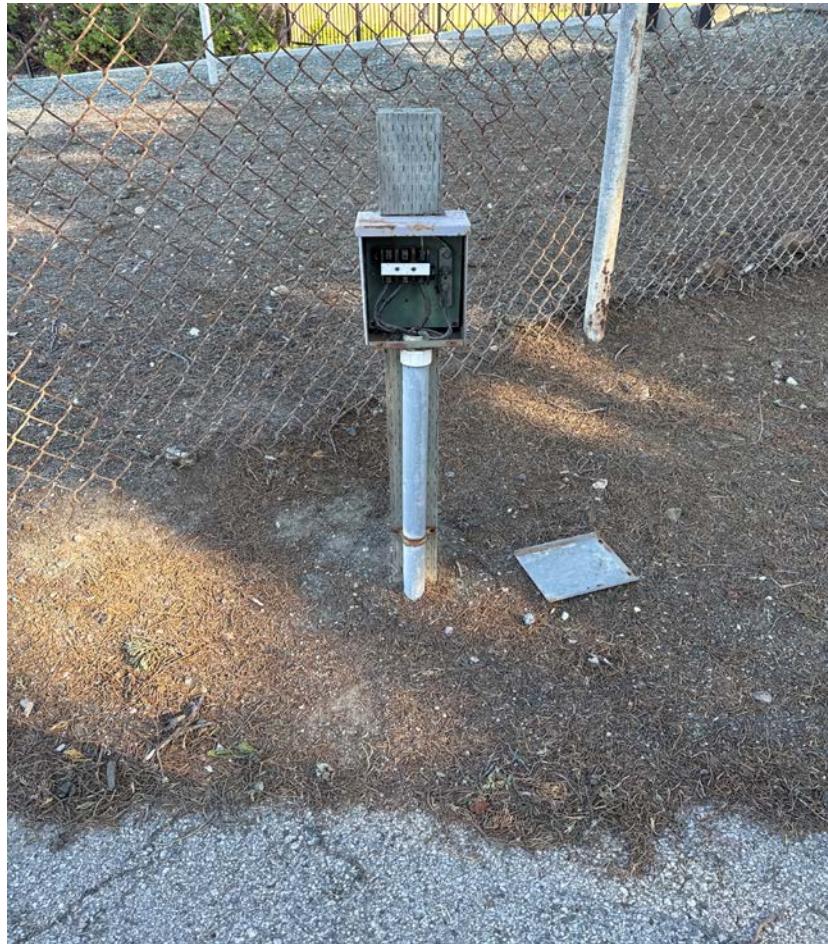
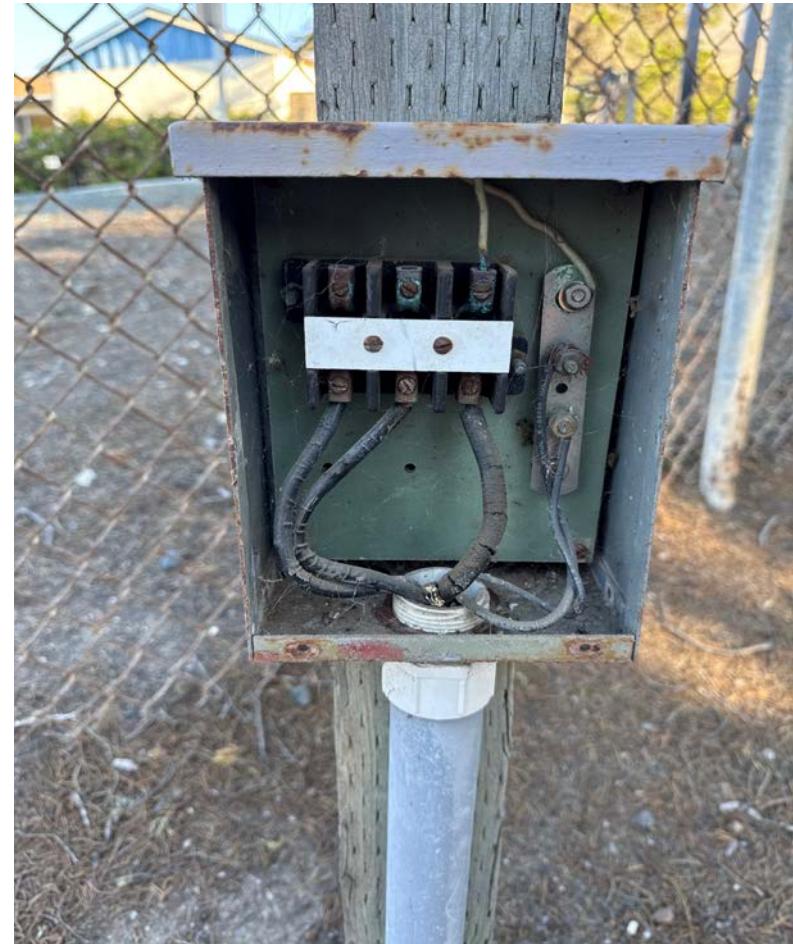
2025 CP Survey – Pump Station A

Asset Repaired	Location	Deficiency Description	Repair Performed
TR-Alpha	Pump Station A	Rectifier (Alpha) has a broken negative structure cable.	Established structure negative
