## Memorandum

Subject: Tree Assessment at 2777 Flora Street, San Luis Obispo

Date: February 17, 2025

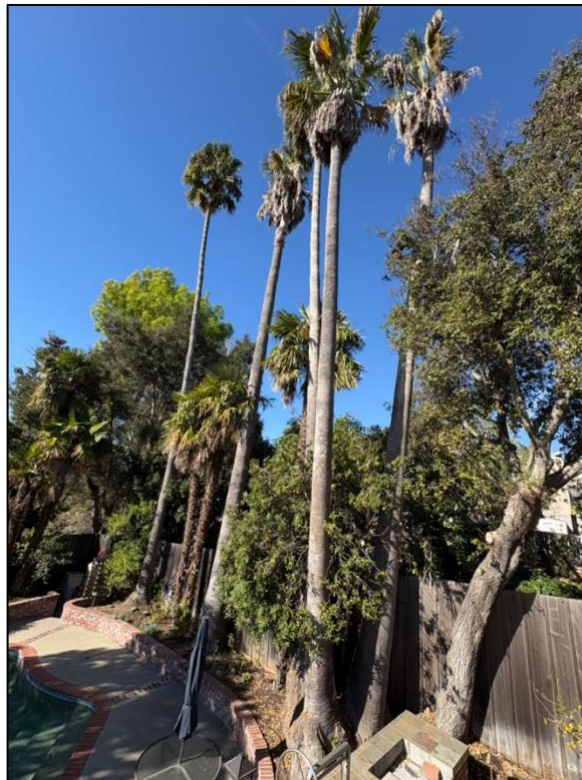
The five subject trees are *Washingtonia robusta*, 17-, 26-inches DSH, and a 21, 22, and 36-inch DSH cluster (Fig. 1).

The palms are in fair health with front tip necrosis and frond dieback typical of the species.

They are 60- to 70-feet in height.

Figure 1: image of the subject palms in their planter.

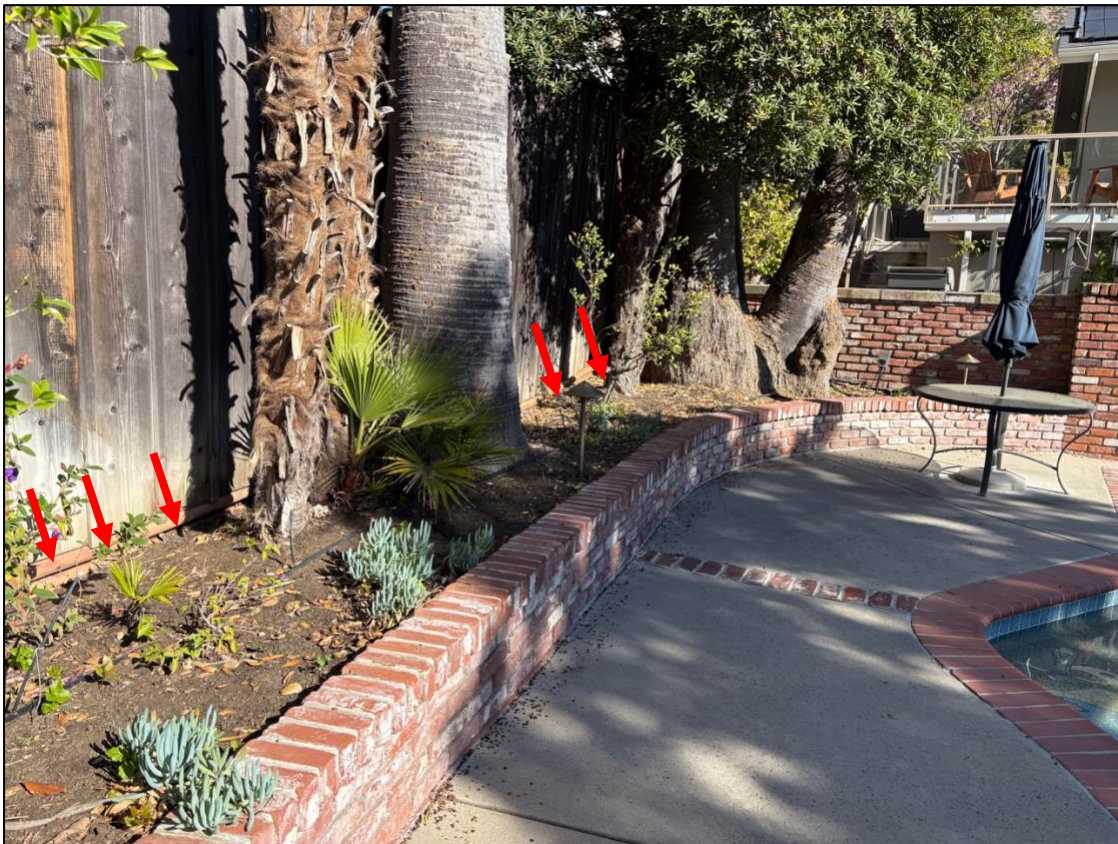
The palms share their planter with a native oak, pittosporum shrubs, and several smaller palm trees (Fig. 3).

*Figure 3: the narrow planter the palms are growing in (red arrow showing the heat pipe that need replacement).*

Lastly, you expressed that the pool's solar water heater piping needs repairing and cannot be done without the palms removed. I have confirmed that the palm trunks are growing directly into the pipe. Removing and repairing/replacing the pipe would cause irreparable damage to the trunks of several palms.

I recommend that you consider removing the palms to repair the water heater piping. I recommend that you:

- An application for removal be prepared and submitted. If removal is granted, remove the palms and perform repairs to the infrastructure as soon as possible. Replace as required.

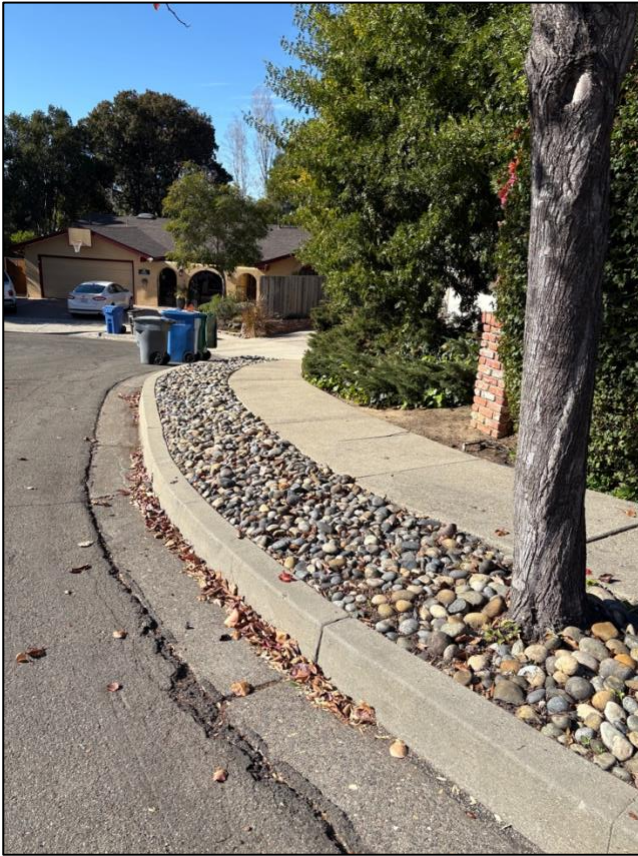
*Figure 4: potential replanting locations along El Paseo Court.*

Removal of these palms would likely require replacement. We have determined that at least three (3) replacement trees could be located along the street frontage of El Paseo Court (Fig. 4). Other trees can be located within the front yard landscaping.
