**Condition Survey**

Client: Jack House, City of SLO

Patina Conservation Studios

Year: 2019

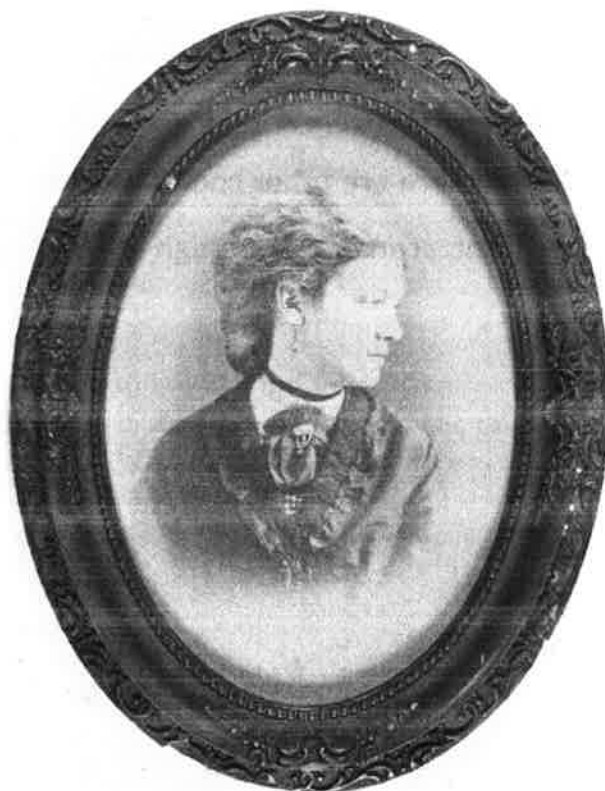
**Material:** paper, plaster**Accession #:** 5.3.58**Dimensions:** 22 Height 2 Width 16.5 Length (cm) Measurement of: frame**Type of item:** Framed photograph of E.B. (written on back) #of parts: 2**Condition:** Fair

**Condition notes:** Photo appears to be possibly faded around the edges. The plaster on the frame is damaged on the bottom left, there is a crack in the frame in the upper left hand corner, appears to be an old photograph with some discoloration on the cut edges of the paper.

The photo should be scanned and a copy made and reframed. The original should be repackaged in archival materials and stored. The frame could be repaired if it is deemed historically significant.

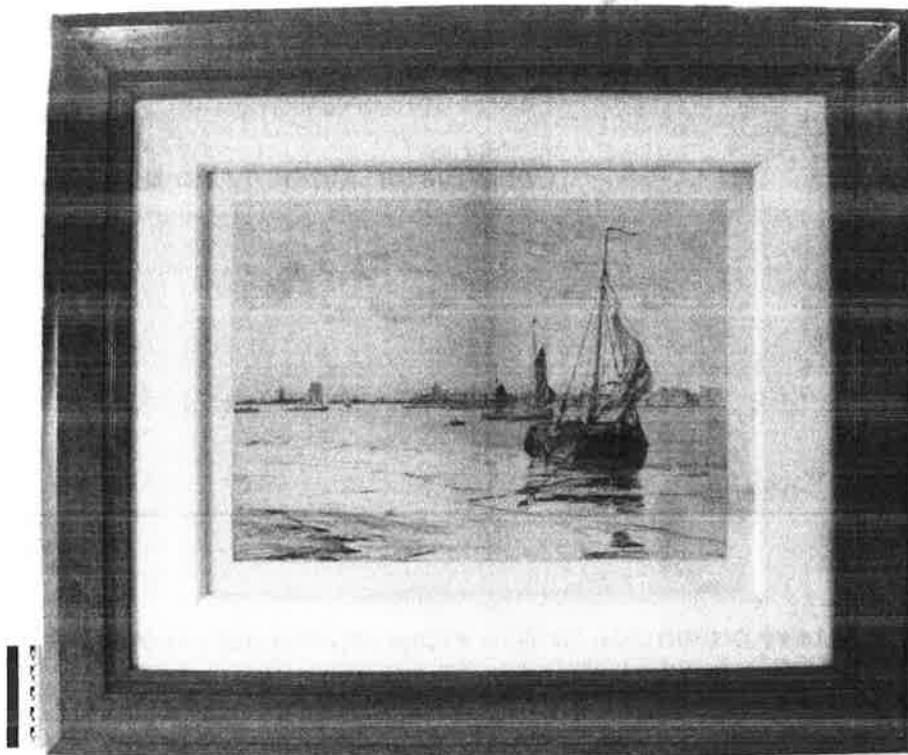
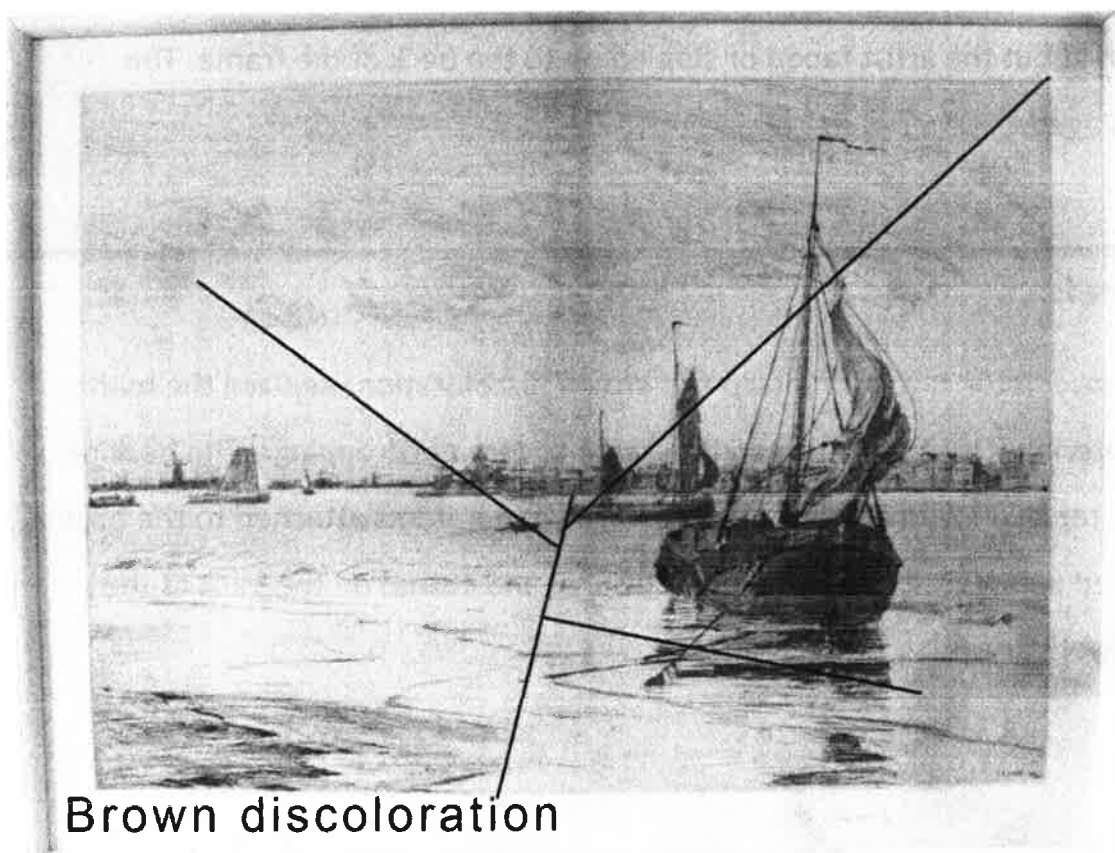
**Material:** drawing/print**Accession #:** 5.4.13**Dimensions:** 72.5 **Height** 0.8 **Width** 84.5 **Length (cm)** **Measurement of:** frame**Type of item:** Sail boats by C.A. Platt 1888 **#of parts:** 2

**Condition notes:** The drawing is very brown due to light exposure and age. The drawing appears to be clean. The frame is in good condition. The mattle appears to be ageing. There are little dots on the frame possibly from insect debris or flies. The backing paper is old and there are signs of past water damage around the edges. There is an old paper with information about the artist taped or stapled on to the back of the frame. The backing paper is aged.

See if a paper conservator can fix or lessen the brown discoloration. Replace the matte with archival materials. Dry and wet clean the frame to remove droppings. The backing paper should be replaced with archival materials. The paper items attached to the back should be scanned and placed into archival enclosures and stored on the back of the frame or in archival storage.

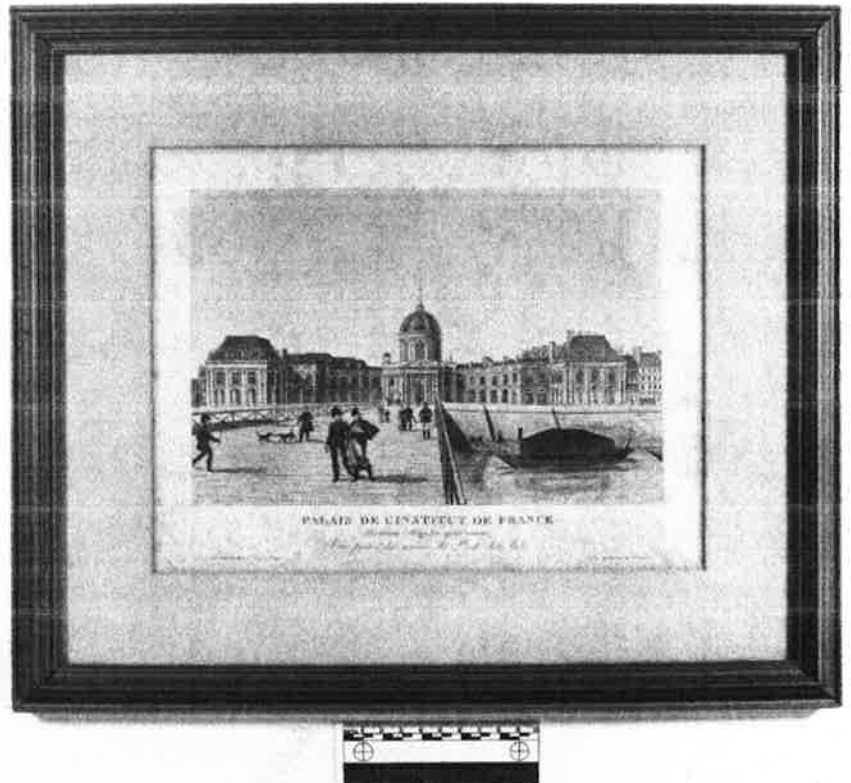
**Material:** paper, ink**Accession #:** 5.4.15**Dimensions:** 35.6 Height 1.8 Width 42 Length (cm) **Measurement of:** frame**Type of item:** "Palais De L'Institut de France" colored print **#of parts:** 2**Condition:** Poor

**Condition notes:** The surface of the print is covered in brown spots possibly due to ageing or foxing. The matte edge is orange indicating ageing. The frame is in good condition. The backing paper shows signs of animal or insect damage.

The original should be sent to a paper conservator to see if the brown spots can be removed. The original should then be scanned, reproduced and stored. The mattee should be replaced with an archival matte. If the original is going back in the frame then the glass should be replaced with museum glass and the backing paper replaced.

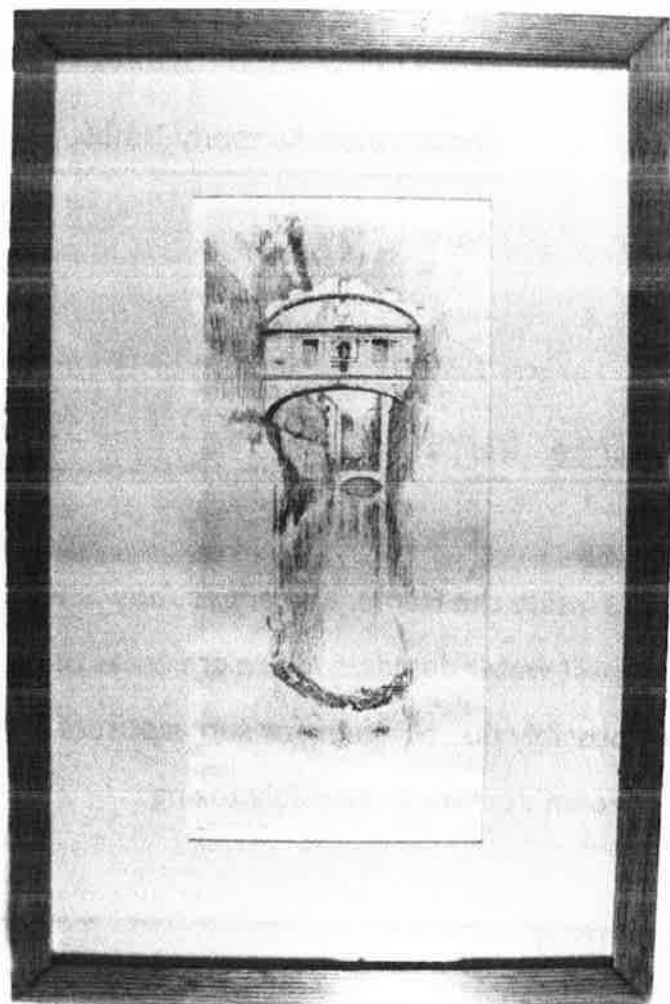
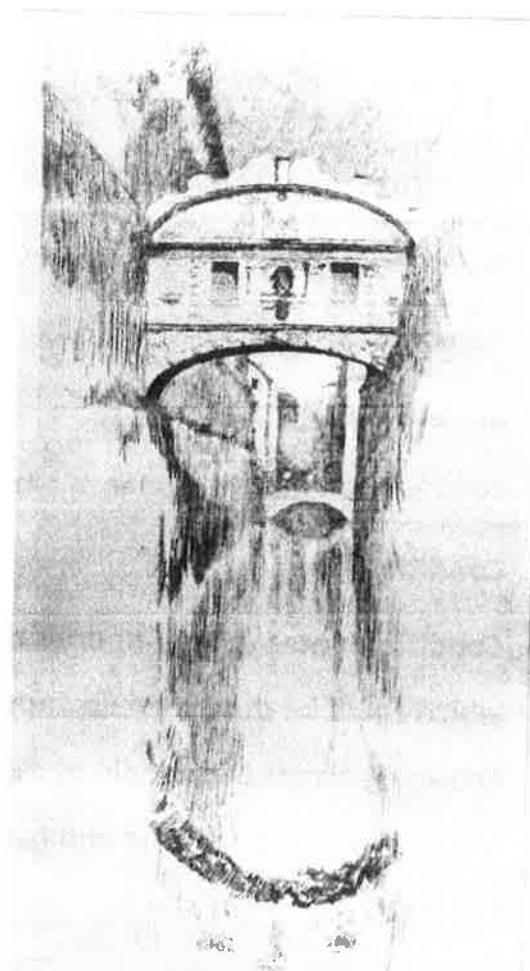
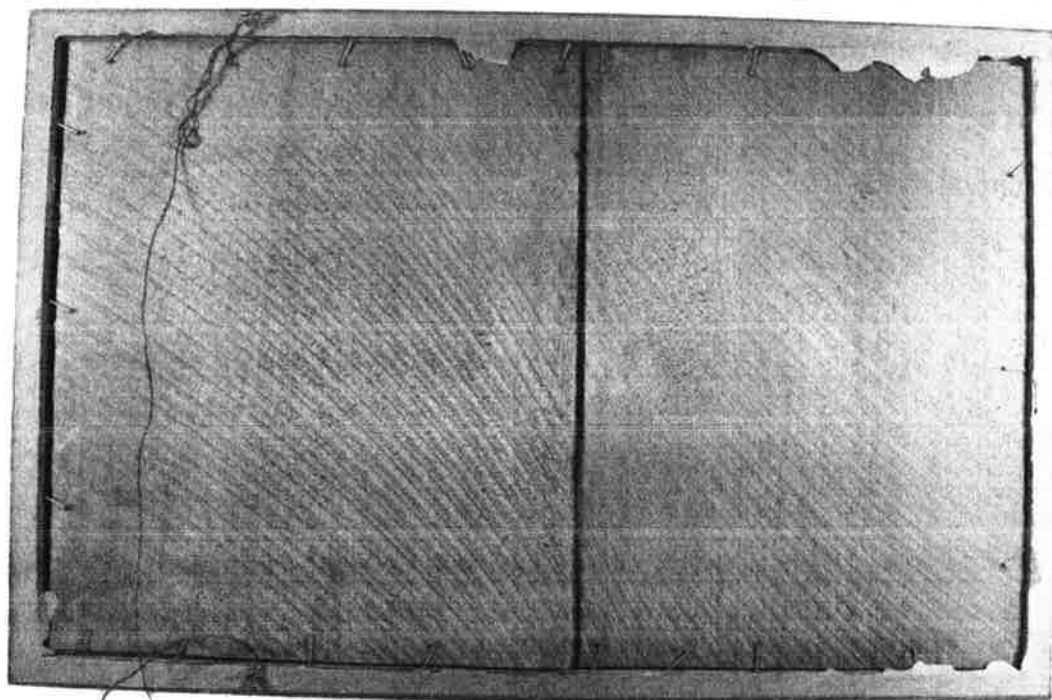
**Type of item:** Etching/print of a <sup>bridge</sup> ~~bride~~ in Venice **#of parts:** 3

**Condition notes:** The print does not lay flat inside the frame. The edges show a waviness which could be due to excess humidity or past water damage. There are areas of browning across the middle of the image possibly due to ageing or sun exposure. The matte appears to be aged and has a few brown dots on it - possibly foxing.

The print should be dry cleaned and sent to a paper conservator for flattening and to address the brown discoloration. The matte should be replaced with archival materials. The image should be scanned, reproduced and stored. The backing paper should be replaced with archival material.

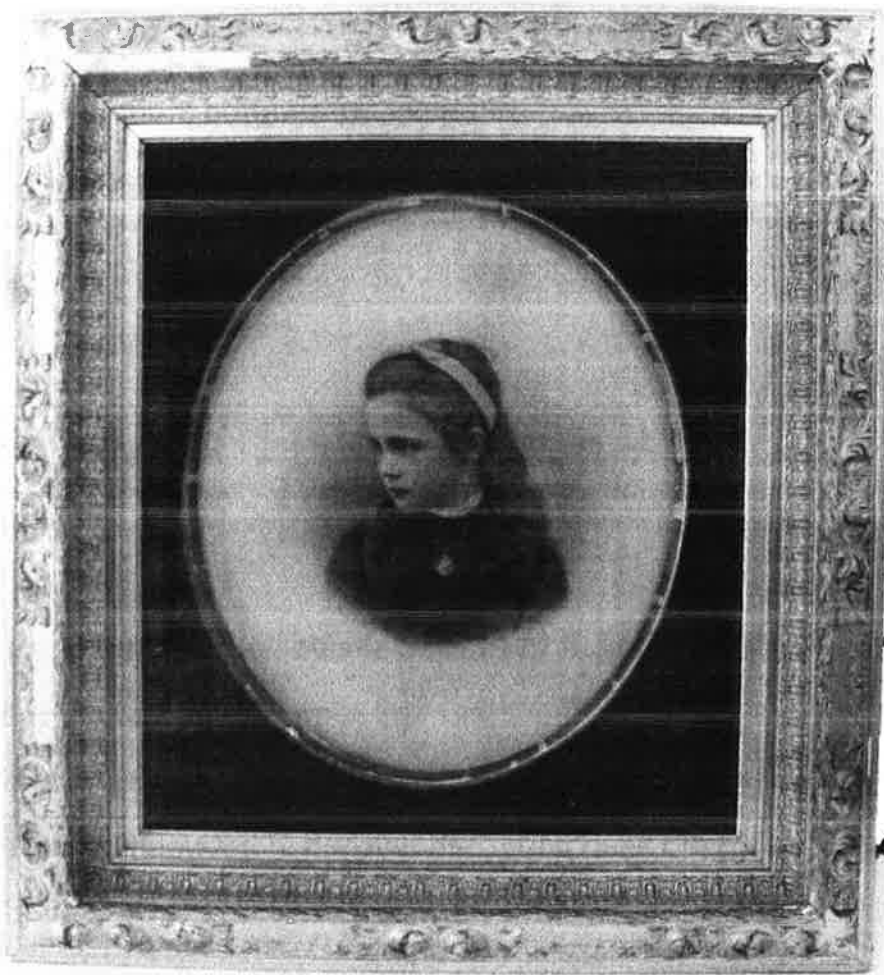
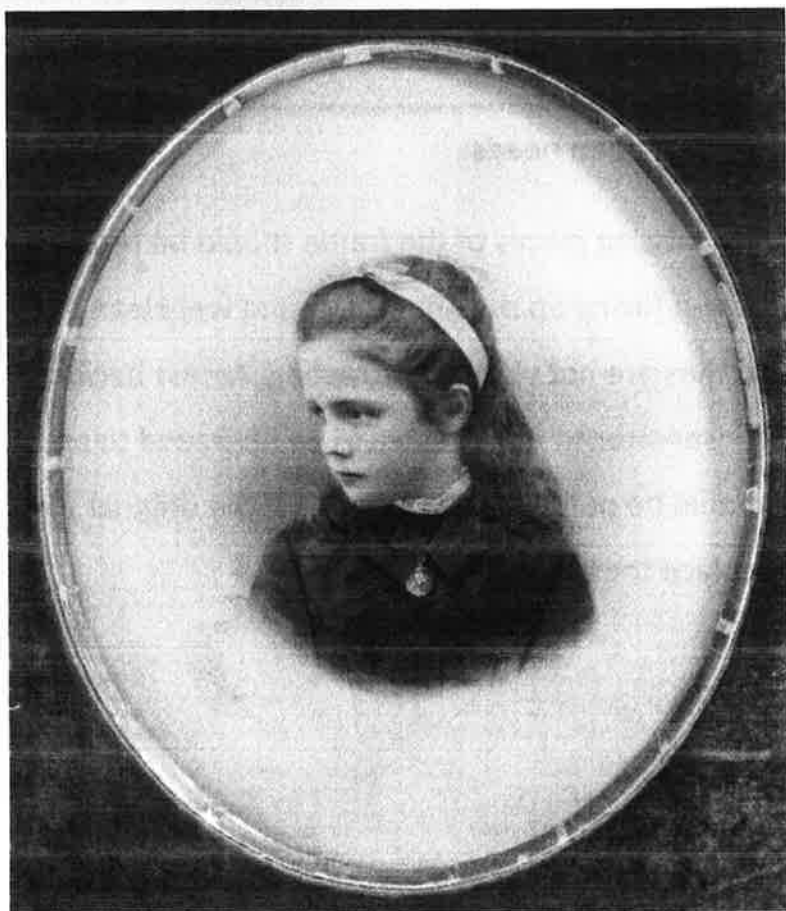
**Material:** drawing, frame**Accession #:** 5.4.23**Dimensions:** 76 Height 7 Width 68.5 Length (cm) Measurement of: frame**Type of item:** Drawing/Photo of Little girl in velvet and gold frame #of parts: 2**Condition:** Fair

**Condition notes:** The frame backing is wood. It used to be sealed with backing paper but the paper is gone. Frame pieces have fallen off in areas and some small areas are missing. The velvet is in good condition. There is old adhesive on the back of the frame probably from the old backing paper. There is old aged paper sandwiched in between boards. There are signs of past water damage on the frame back especially on the right hand side. The frame is dusty. The image shows signs of foxing and brown dots.

The missing pieces of the frame should be replaced. Have a paper conservator look at the brown foxing on the image. Dry and wet clean the frame. Inpaint missing areas on frame so they are not visually distracting. Assess backing with a professional framer or paper conservator to see if it should be upgraded to archival materials or if a reproduction should be put back in the frame. If the original stays in the frame, museum glass should replace the original glass.

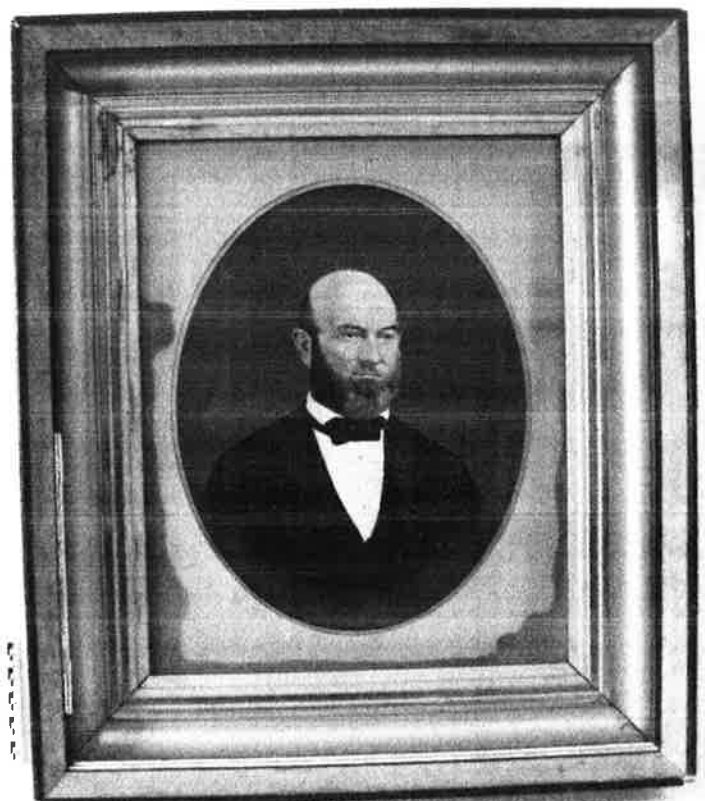
**Material:** painting**Accession #:** 5.4.29**Dimensions:** 58.5 Height 7.3 Width 48.5 Length (cm) Measurement of: frame**Type of item:** Painting of R.E. Jack (bald man with grey beard) #of parts: 2**Condition:** Poor

**Condition notes:** The matte is water damaged. There is dust inside the frame. The frame is missing pieces in several areas. There is wood/plaster coming up on top of the frame. The frame is dusty. The gold paint on the frame is cracking in the lower right corner. There is no backing paper present. The frame backing is wood and the paper underneath looks very aged and dirty. There are scrapes on the back of the frame.

The frame and the painting need to be dry cleaned. The matte should be replaced with archival materials. The wood backing should be replaced if the original is going to stay in the frame. The frame and wood at the top of the frame can be repaired. Repair any missing areas on the frame and inpaint to match. Write the accession number on the frame and the painting back.

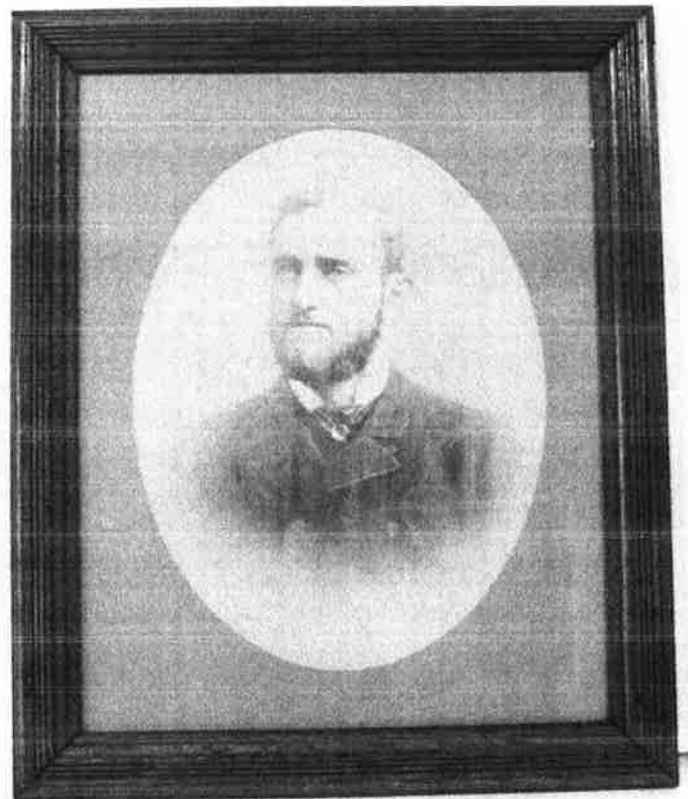
**Material:** photograph, frame**Accession #:** 5.4.30**Dimensions:** 59.5 Height 2 Width 49.3 Length (cm) Measurement of: frame**Type of item:** Framed photo of man *Johnny Miller* #of parts: 2**Condition:** Fair

**Condition notes:** The matte is aged and cracking. The frame glass is dusty. The photograph appears to be in stable condition. The backing paper is old and shows signs of water stains. There is a wood backing under the paper. There are dots of something that looks like insect poo on the frame.

The photograph should be scanned and reproduced. The original photograph should go into archival storage. Otherwise, the wood backing should be removed and replaced with something archival. The backing paper should be replaced with archival materials. The frame should be dry and wet cleaned where necessary. The glass should be replaced with museum glass if the original is going to stay in the frame. The matte should be replaced with something similar but of archival quality.

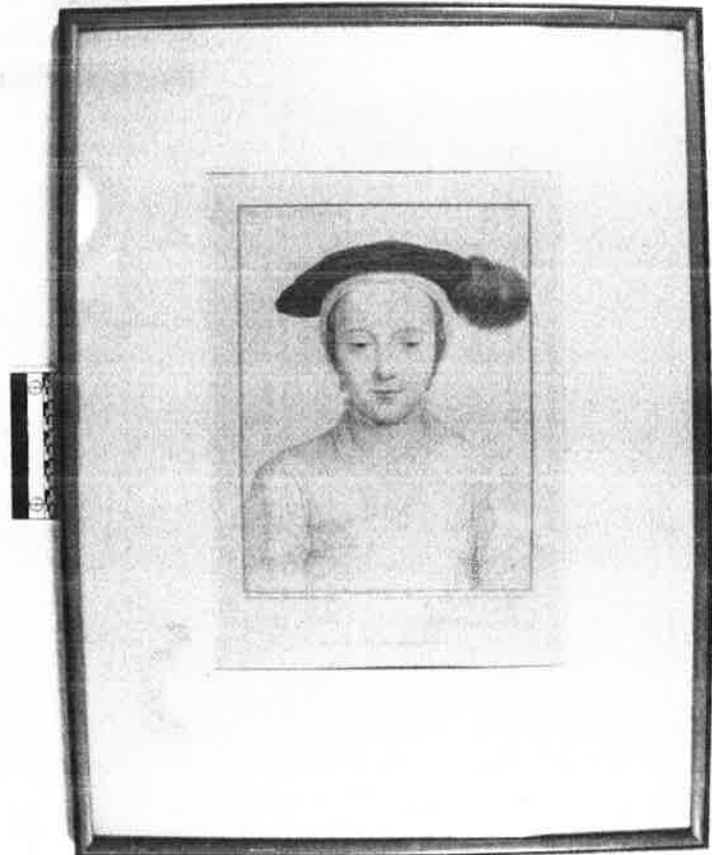
**Material:** paper**Accession #:** 5.4.33**Dimensions:** 57.7 Height 1 Width 43.5 Length (cm) Measurement of: frame**Type of item:** "The Lady Edmond" print from engraving #of parts: 2**Condition:** Fair

**Condition notes:** The print is in good condition. The matte is yellowed and aged. The matte and print both appear to be dusty. The frame has nicks on the edges from handling but is in sound condition. The note written on the back says "print purchased by Ethel Easton Jack" 1920s. The backing paper is heavily aged

The print, glass and frame should be dry cleaned. The matte should be replaced with an archival matte. The backing paper should also be replaced with archival material. The print should be scanned, reproduced and the original stored. The copy should go back into the frame.

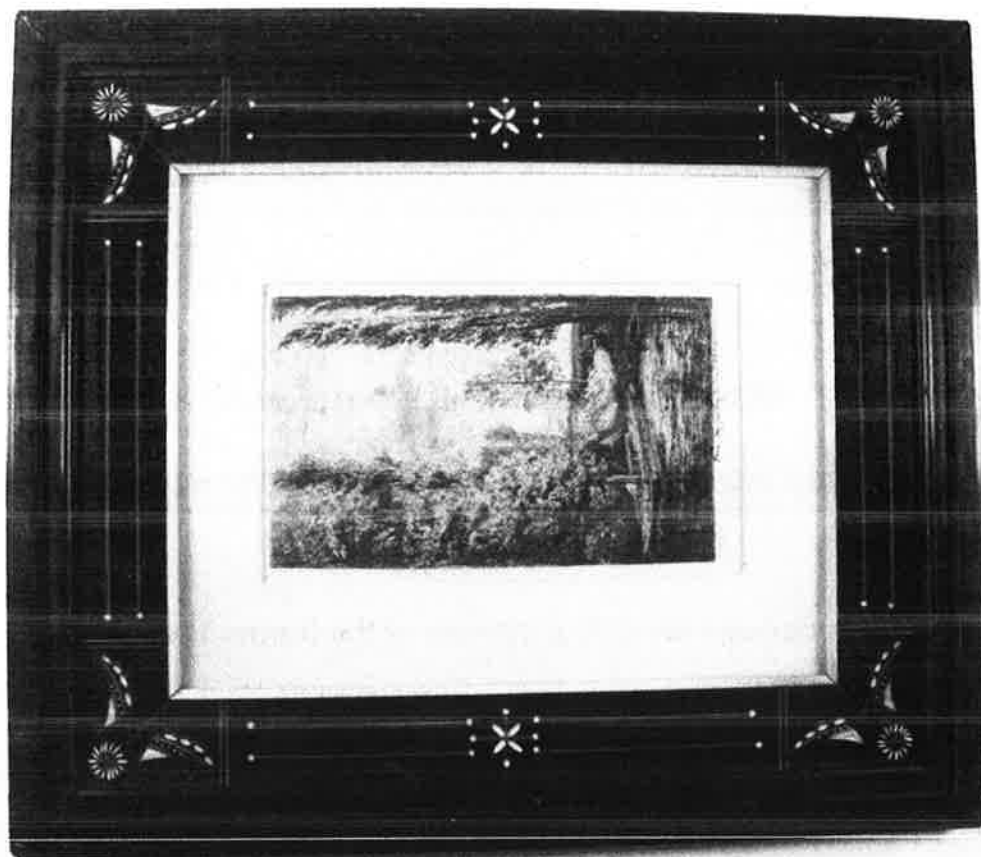
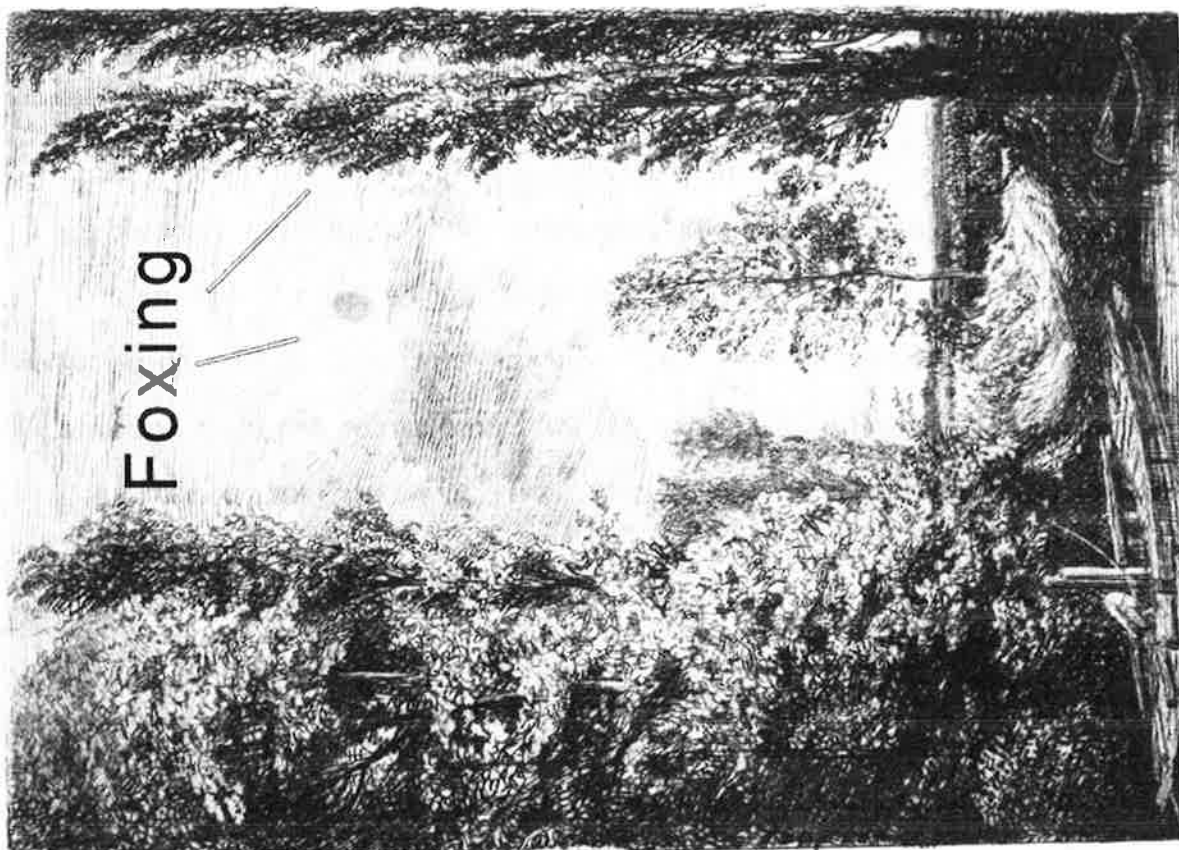
**Type of item:** print of etching, "Paris. Imp por Aug Delatre F.bourg Poissonnere 145"

**Condition notes:** The frame is very attractive and in very good condition. The corners of the frame show some damage. The matte appears to be a little dirty. There are two brown spots on the print possibly due to foxing. The back of the frame is wood. There is a "No. 47" stamped on the back. It used to have backing paper but it is missing.

The print and matte need to be dry cleaned. The foxing should be looked at by a paper conservator. The wood backing should be removed if the original is going to stay in the frame. Otherwise, a scanned copy could be put in the frame and keep the wood backing. The frame needs dry cleaning to remove dust.

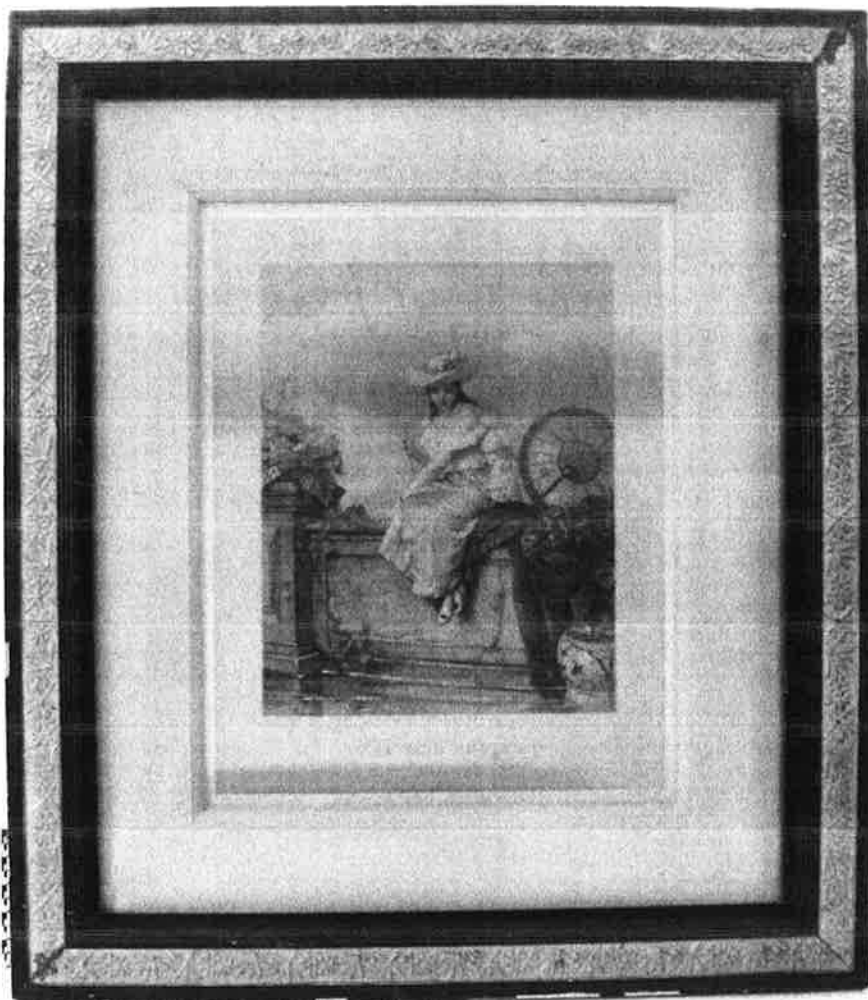
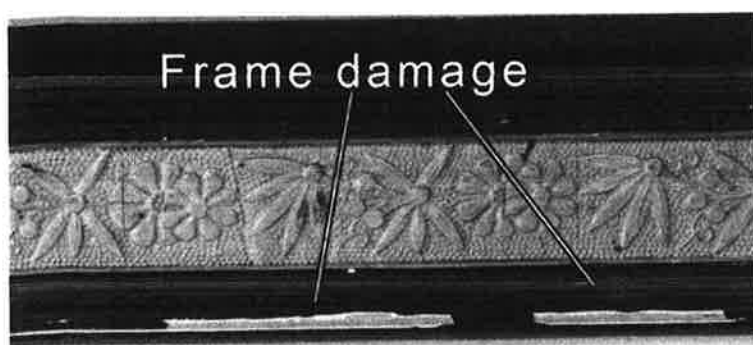
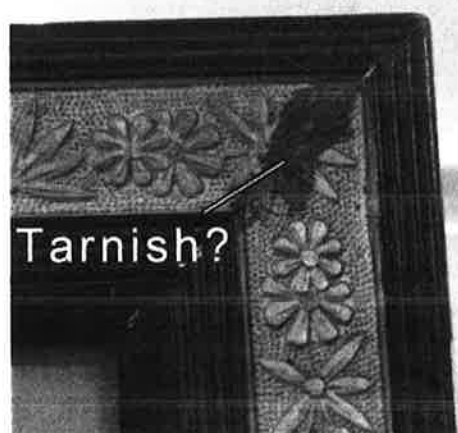
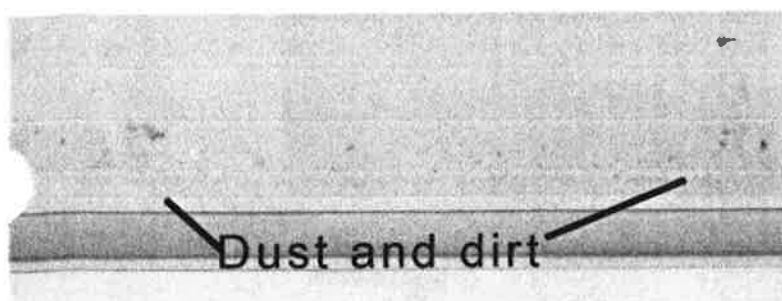
**Material:** print, frame**Accession #:** 5.4.40**Dimensions:** 68.4 **Height** 2 **Width** 59.1 **Length (cm)** **Measurement of:** frame**Type of item:** "The Fair Angler", print **#of parts:** 2

**Condition notes:** The image is very discolored and dusty inside the frame. It almost appears moldy towards the bottom of the image. There are brown bands of discoloration through the middle of the image. The frame is in good condition but it is missing black in a few areas and the gold is discolored on the lower left and upper right. The old backing paper is aged and brittle and fragmented. The frame has a wood backing and there is old adhesive present. There are signs of mold or dirt on the back of the paper.

The print needs dry cleaning and to be checked for mold. If mold is present, it will need to be wet cleaned to kill the mold. The frame and glass need dry cleaning. The matte should be replaced with an archival matte. The image should be scanned and reproduced with the copy being reframed. Talk to a paper conservator about removing the brown discoloration and possible mold. Inpaint areas on the frame missing black paint. Remove the old adhesive from the back and replace with new backing paper. If keeping the original in the frame, the wood backing should be removed.

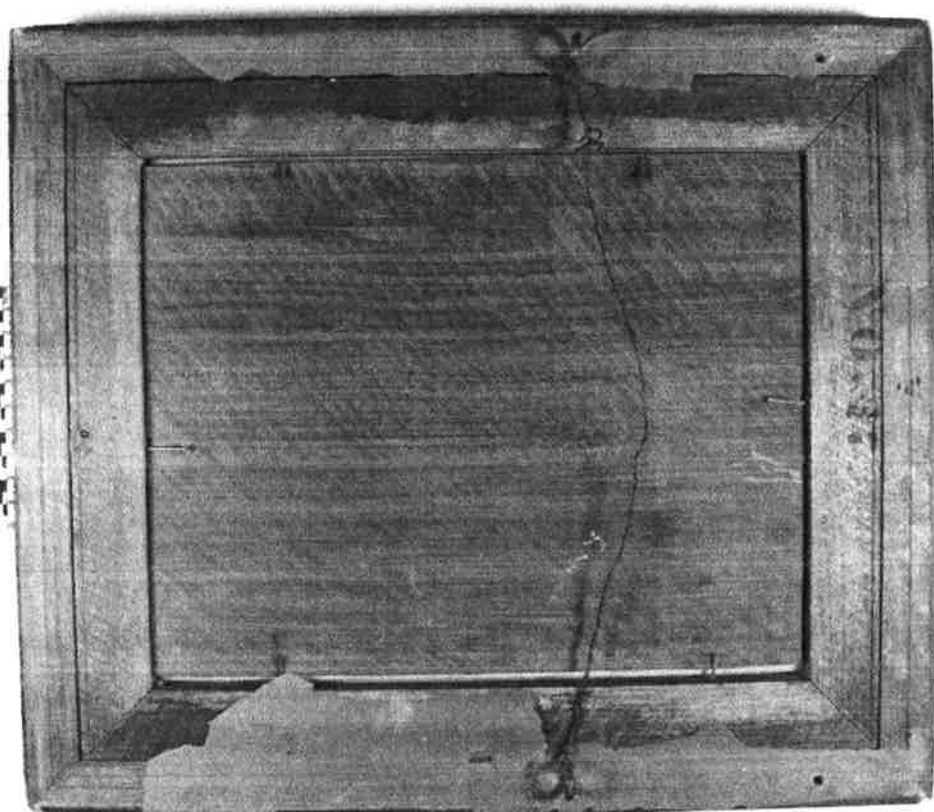
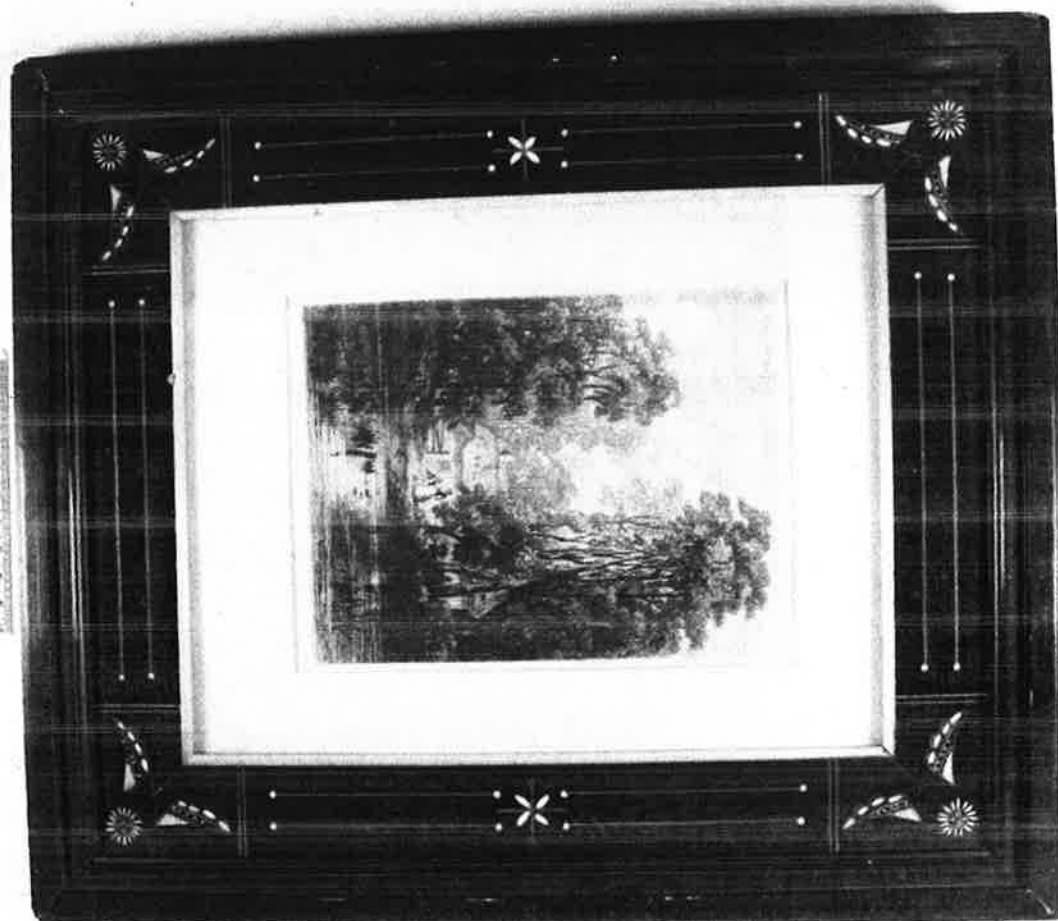
**Material:** paper**Accession #:** 5.9.200**Dimensions:** 36 Height 3 Width 31 Length (cm) Measurement of: frame**Type of item:** print/charcoal drawing of woman and boy gathering water #of parts: 2

**Condition notes:** There is damage on all four corners of the frame. The matte and drawing appear dirty/dusty. There is some foxing present towards the top of the drawing. Part of the frame is dirty with handling grease. The brown discoloration on the frames white inner moulding is handling grease. It had backing paper but it is gone. The back is stamped with "No. 47".

The matte should be replaced with an archival matte. The backing paper should be replaced to keep dust off the drawing. The drawing should be taken to a paper conservator for dry cleaning and to address the brown discoloration. The frame should only be handled with gloves on. The corners of the frame can be repaired if desired. The wood backing should be reconsidered in the original is going back into the frame.
