### Cultural Heritage Committee AGENDA

Monday, October 25, 2021, 5:30 p.m.

#### RECOMMENDATION

Recommend to the City Council that the City enter into a Mills Act historic property contract with the property owners, to encourage maintenance and restoration of the historic property at 531 Dana Street (Dana/Barneberg House).

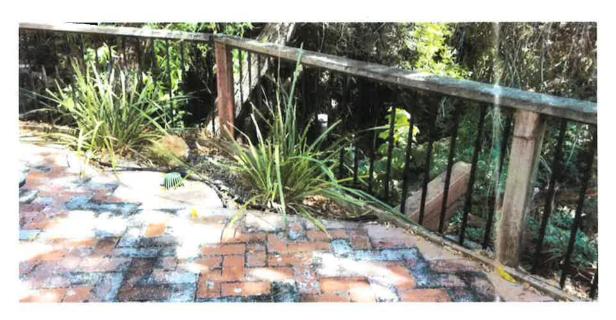
$Figure \ 1-Retaining \ wall \ at \ backyard \ upper \ patio.$

Due to the insufficient soil-retention system, future soil and retaining wall movement is expected to continue until complete slope failure occurs. It is recommended that all wood retaining walls be replaced with reinforced concrete or masonry walls with proper foundations designed by a licensed civil or structural engineer.

The estimated complete design and construction costs for a retaining wall project of this extent is estimated to range between \$80,000 and \$100,000. This estimate includes not only the cost of materials and construction, but also hiring a Geotechnical Engineer to provide soil properties and design data, a Civil Engineer to survey the slope and back portion of the property, and a Civil/Structural Engineer to provide the structural design of a new retaining wall system, all of which were clearly not provided for the construction of the current wall that is failing.

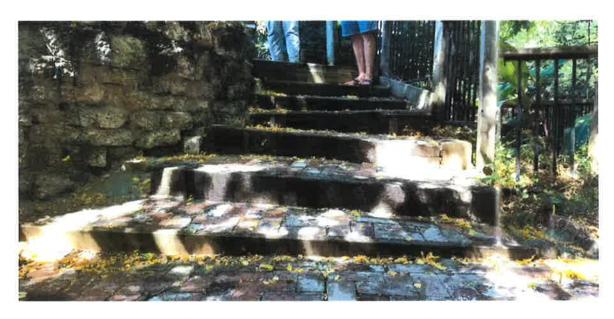
$\label{eq:Figure 2-Sloping steps} \textbf{Figure 2-Sloping steps and lower patio.}$

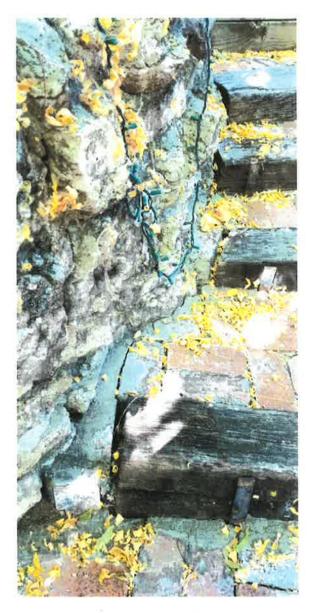
Figure 3 – Lower level steps pulling away from existing stone wall.

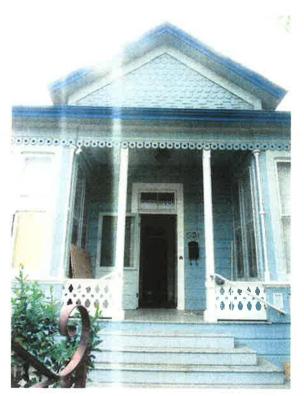
The one story residence is clad in ten inch shiplap siding with hand wrought nails in evidence. The flat roof covering the bays in front surround the high gable, one of several roof lines in the unusual structure (Figure 16) (Appendix B). Two patterns of decorative shingles are used under the front facing gable that covers a recessed porch. Victorian flat sawn balusters support the railing with a post on either side at the top of the stairs leading onto the porch (Figure 16).

Figure 16: Centered Front Entry

The two large rectangular square bays in the front are the primary features. The bays have slender columns in-set on the corners that add an elegance to the design. Each bay has two narrow windows on each side and three across the front. They are all the same size one-over-one double hung sash with a continuous sill that wraps around the bays above inset panels. The windows have screens that are hung from the top. Under the eaves and vertical board frieze, a saw cut border of circles wraps around the bays above the windows and continues across the porch entry (Figures 16 and 17).

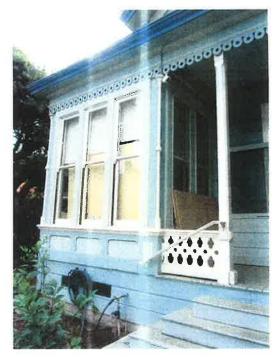
Figure 17: East Corner Bay
