ARCHITECTURAL WORKSHEET

1. Address Block 136 1720 MORRO STREET

Historic Name: Morris Home

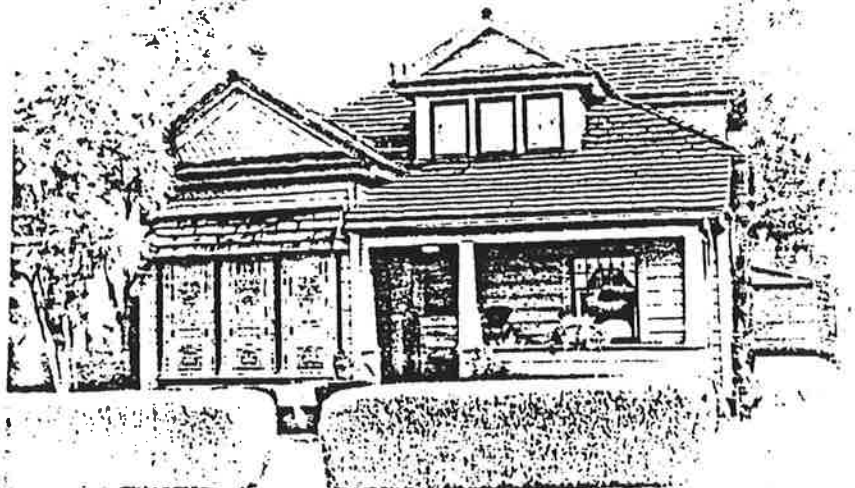
Address: 1720 Morro

This is a 1-1/2 story wood frame building. The roof ia a multi gabled hipped style with two dormers. The roof has wood shingles, a box cornice, and a simple frieze. The dormers have stickwork in their pediments. The house has shiplap siding and a raised concrete block foundation. The closed gable has a wood shingle pent with diamond and fishscale shingles in the pediment. The recessed porch is supported by two columns and two pilasters. These are of a modified Californian Bungalow style. The closed rail has shiplap siding. The right front window is a rare 10/1 Colonial sash style. The yard is well maintained.

Construction Date: Pre 1903 Present Condition: Excellent

Alterations: There are three large stained glass windows and a wood shingle shed roof below the front gable; three small stained glass windows are located in the front dormer.
