FUTURE IMPROVEMENTS 531 DANA STREET

Stork, Wolfe & Associates

Re: 531 Dana Street
Structural Inspection

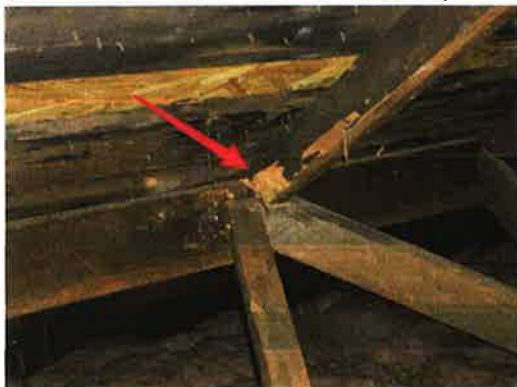
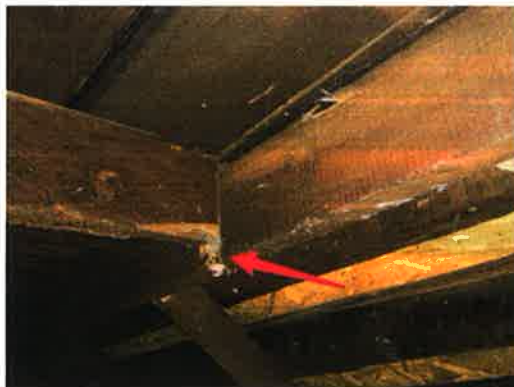
E&C **SU** **FI** **103:** Attic framing found damaged and improperly repaired in many locations. Further evaluation and corrections recommended. Contact a qualified professional.
