2025 Whale Rock 30" Waterline Cathodic Protection Survey

Report – Cathodic Protection Services

Issued To: **City of San Luis Obispo**

Document ID: **ACUUS-J212126-RSV-0.0**

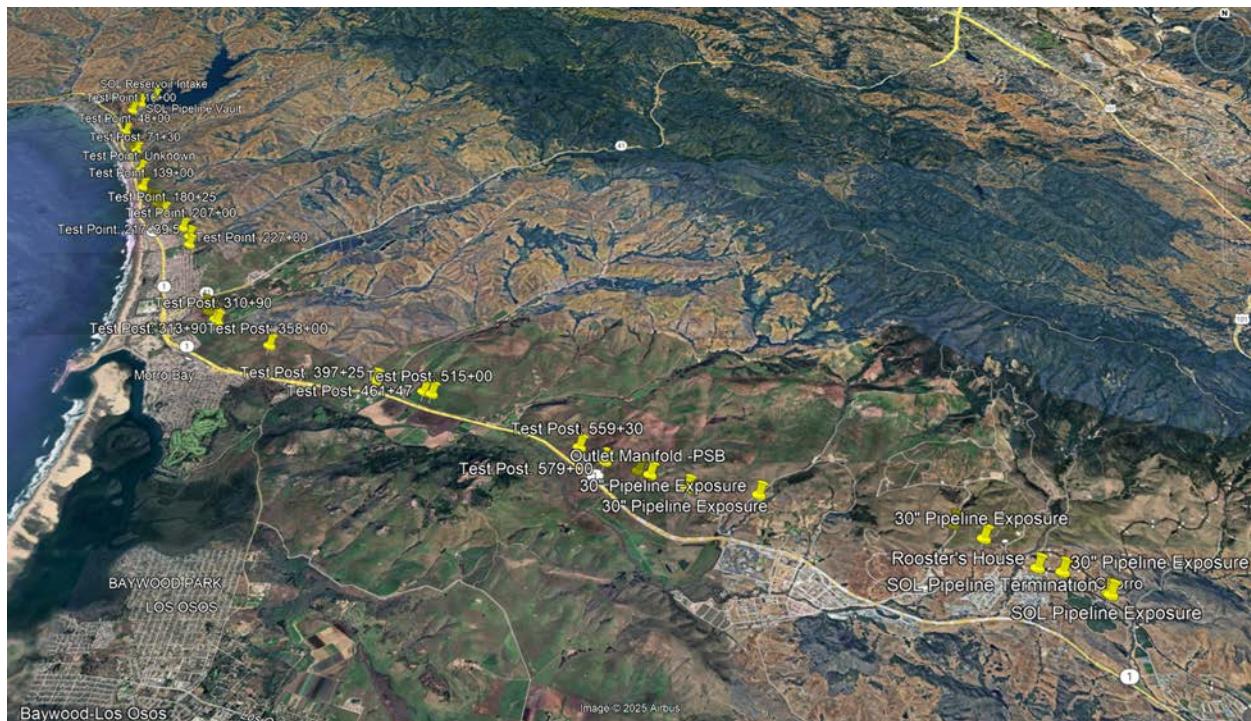
FIGURE 1: TEST STATION LOCATION – ACTUAL VIEW

Test station placement along the 30" Whale Rock waterline begin at station# 10+00 and end at station# 602+50. There are no additional test station locations between Pump Station "B" and the termination of the waterline at the regional treatment plant, approximately 4.5 miles.
