## Memorandum

Subject: Tree Assessment at 2777 Flora Street, San Luis Obispo

Date: February 17, 2025

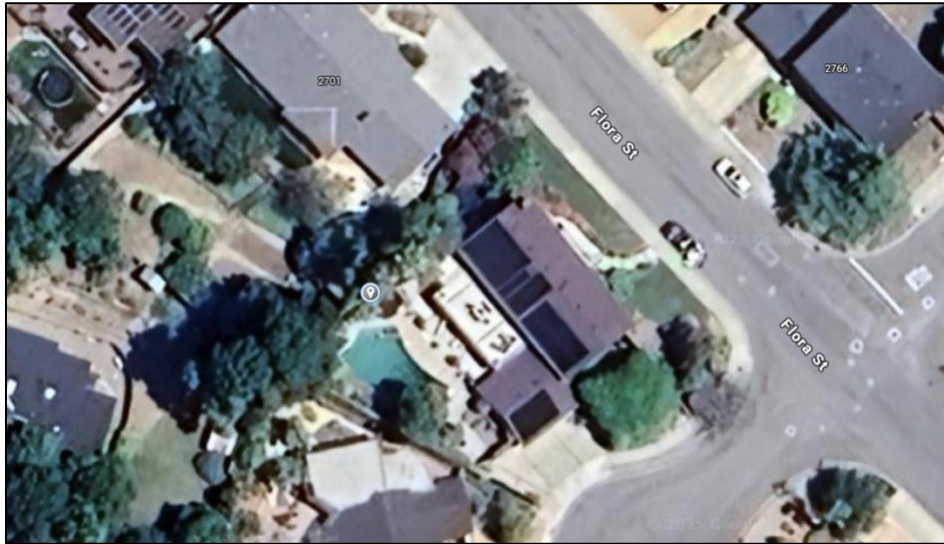
They are growing in a narrow, raised planter bordering the northwest property line in the backyard of the 2777 Flora Street property (Fig. 2).

*Figure 2: subject palms location at 2777 Flora Street (grey marker).*
