## **CULTURAL HERITAGE COMMITTEE AGENDA REPORT**

**SUBJECT:** REVIEW OF THE REPAIR AND RENOVATION OF THE ALLEN HOUSE (MASTER LIST HISTORIC RESOURCE), INCLUDING REPLACEMENT OF WINDOWS; INSTALLATION OF SKYLIGHTS WITHIN THE BUILDING ROOF; AND REMOVAL OF A ROOF CANOPY AT THE REAR OF THE BUILDING, AND ITS REPLACEMENT WITH

**PROJECT ADDRESS:** 1700 Osos St.

**FILE NUMBER:** ARCH-0145-2021

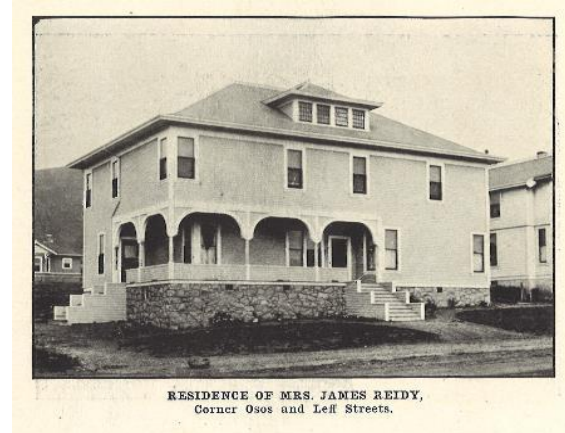
Figure 2: 1700 Osos (1904)

The property is developed with a two-story dwelling, estimated to have been built around 1900, of an architectural style described in the City's Architectural Worksheet for the property (Attachment B)<sup>1</sup> as "Railroad Vernacular with Neo-Classical influence" or "California Renaissance." Among the building elements described are its medium-sloped belled hip roof, boxed soffit, continuous smooth frieze band, centered dormer with four 20-pane windows (visible only on rear elevation, of which three are extant), center recessed porch with straight-top arch (remnant of a larger corner porch subsequently enclosed, see Figure 2), rows of large double-hung windows on each floor, with wide flat trim and bracketed lug sills, and clapboard siding and stone base.

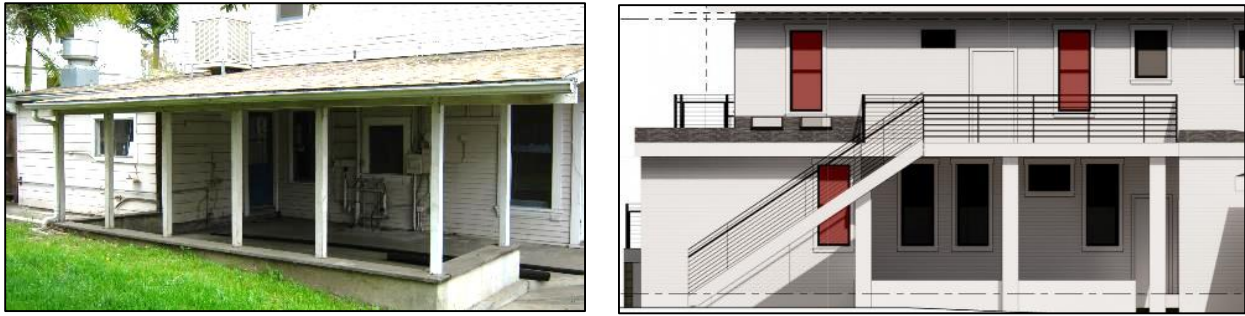
**Figure 3: Patio cover to be demolished (left); replacement deck (right)**

Patio Cover and Deck. At the rear elevation, a patio covering is proposed to be removed, to be replaced by a new second-level concrete deck structure with metal guardrails that will also provide a ground-level covered patio area (see Figure 3).

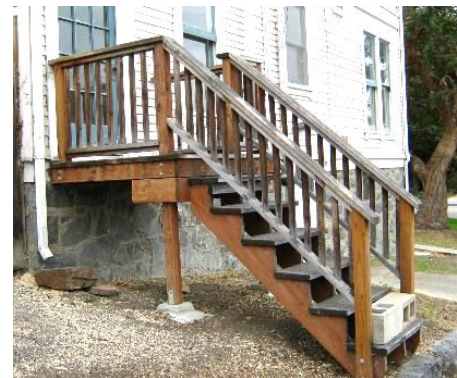
**Figure 4: Leff St. Stairs**

A small stairway on the north elevation (Leff Street, see Figure 4) will be replaced by a small rebuilt stairway with landing. On the other side of the building, on the south elevation, the second-floor stairway, largely out of view from the public right-of-way, will be rebuilt in an improved configuration. The new stairway has a less steep pitch and provides additional egress at a landing in front of a first-floor window (see Detail 54 on Sheet A3.3 in Project Plans, Attachment C).

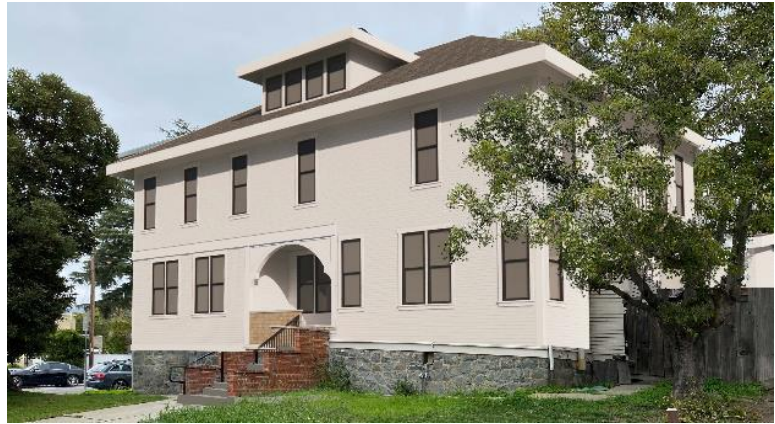
**Figure 5: Rendering, front (Santa Barbara St.) elevation**

The applicant has placed the proposed new deck at the rear elevation of the building, which reduces its visibility and impact, and has limited remaining exterior modifications to minor alterations of an existing stairway, refurbishment of an existing fire escape, and replacement of windows “for like” with purposely selected wood clad replacement windows. The characteristic

wood siding and trim of the building and its surviving porch features are preserved unaltered, with remaining work limited to interior renovations.
