Council Agenda Report

SUBJECT: REQUEST TO REMOVE THE PROPERTY AT 1720 MORRO STREET FROM THE CONTRIBUTING PROPERTIES LIST OF THE CITY'S INVENTORY OF HISTORIC RESOURCES

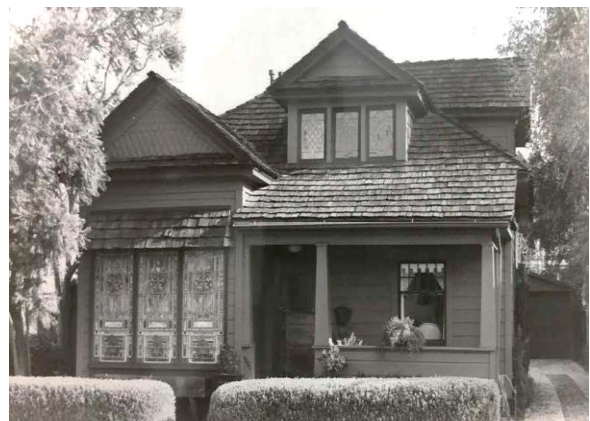
Figure 1: 1720 Morro (1982)

The site is developed with a single-family dwelling (see Figure 1). As described in the applicant's Historic Resource Evaluation, the dwelling appears on a 1905 Sanborn Map, but no permit record establishing a construction date has been found, nor is the architect of the building known. City records (see Historic Resource Information, Attachment D) describe the building as Neo-Colonial or Colonial Bungalow in style and discusses various architectural elements of the building. The applicant's evaluation more specifically describes the style as "Colonial Revival Bungalow."

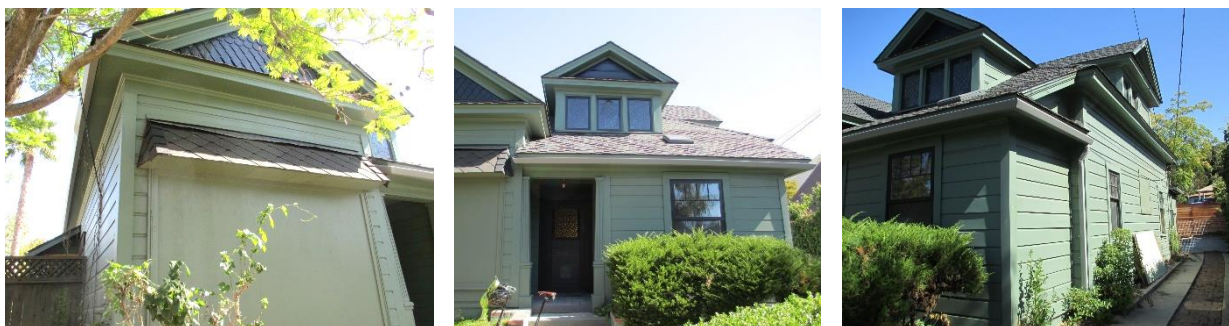
1. Oversized front dormer (by 1949)
2. Large Post-Modern style dormer on rear
3. South facing pedimented dormer (1965-1982)
4. Porch enclosure (by 2017), including modification and fluting of porch columns
5. Removal of 10-over-1 sash window from front façade (behind porch enclosure)
6. Replacement window in front bay (also now removed)
7. North-facing "push-out" addition and window (attached to rear porch enclosure)
8. New window opening in north-facing pediment
9. New window opening (now boarded) between originals on south elevation
10. Full width back porch enclosure

Figure 2: Modifications - bay (left), porch (center), and south elevation (right)

The most visible elevation, the front façade, has been subjected to loss of character-defining features by enclosure of the front porch, loss of the 10 over 1 sash window and modification of porch columns, the addition of an oversize dormer to the hipped roof form, and addition of the shed awning over the large window bay and removal of the original window. Today, observable original elements of the building at large are limited to the pedimented gable and window bay (missing the window from the opening) on the façade, siding on the south elevation (interrupted with a new window opening), siding remaining on some portions of the north elevation, the north-facing dormer (compromised by the added window), and the box cornice and frieze details.

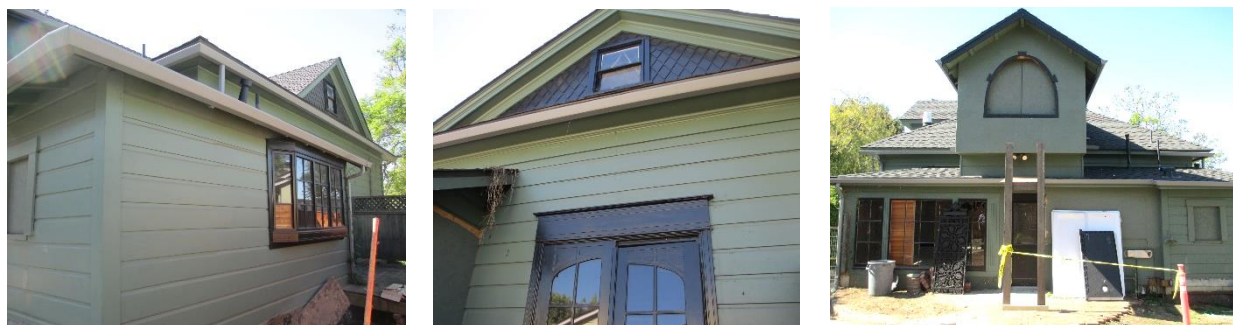
Figure 3: Addition to north elevation (left), added dormer window (center), rear dormer (right)

The loss of integrity discussed in the evaluation centers around the “cluttered and jarring” effect that the modifications have had on the design, materials, workmanship, and feeling of the building in its current state. The upper-floor additions and related outsize dormers have obscured and complicated the original simple pyramid roof form. A recent porch enclosure and modification of porch columns has effectively eliminated the original characteristic porch and entry feature. Removal of the window from the front bay and addition of a canopy has altered this feature, with no remaining documentation to aid in its accurate reconstruction. And enclosures at the front and rear have altered the original building form with significant removal of original wall material. As summarized in the applicant's evaluation:
